**LAKE SINISSIPPI IMPROVEMENT DISTRICT  
ANTHONY ISLAND SHORELINE AND NEAR-SHORE LAKEBED ASSESSMENT  
AND SHORELINE RESTORATION PLAN**

Eco-Resource Consulting, Inc.

January, 2018

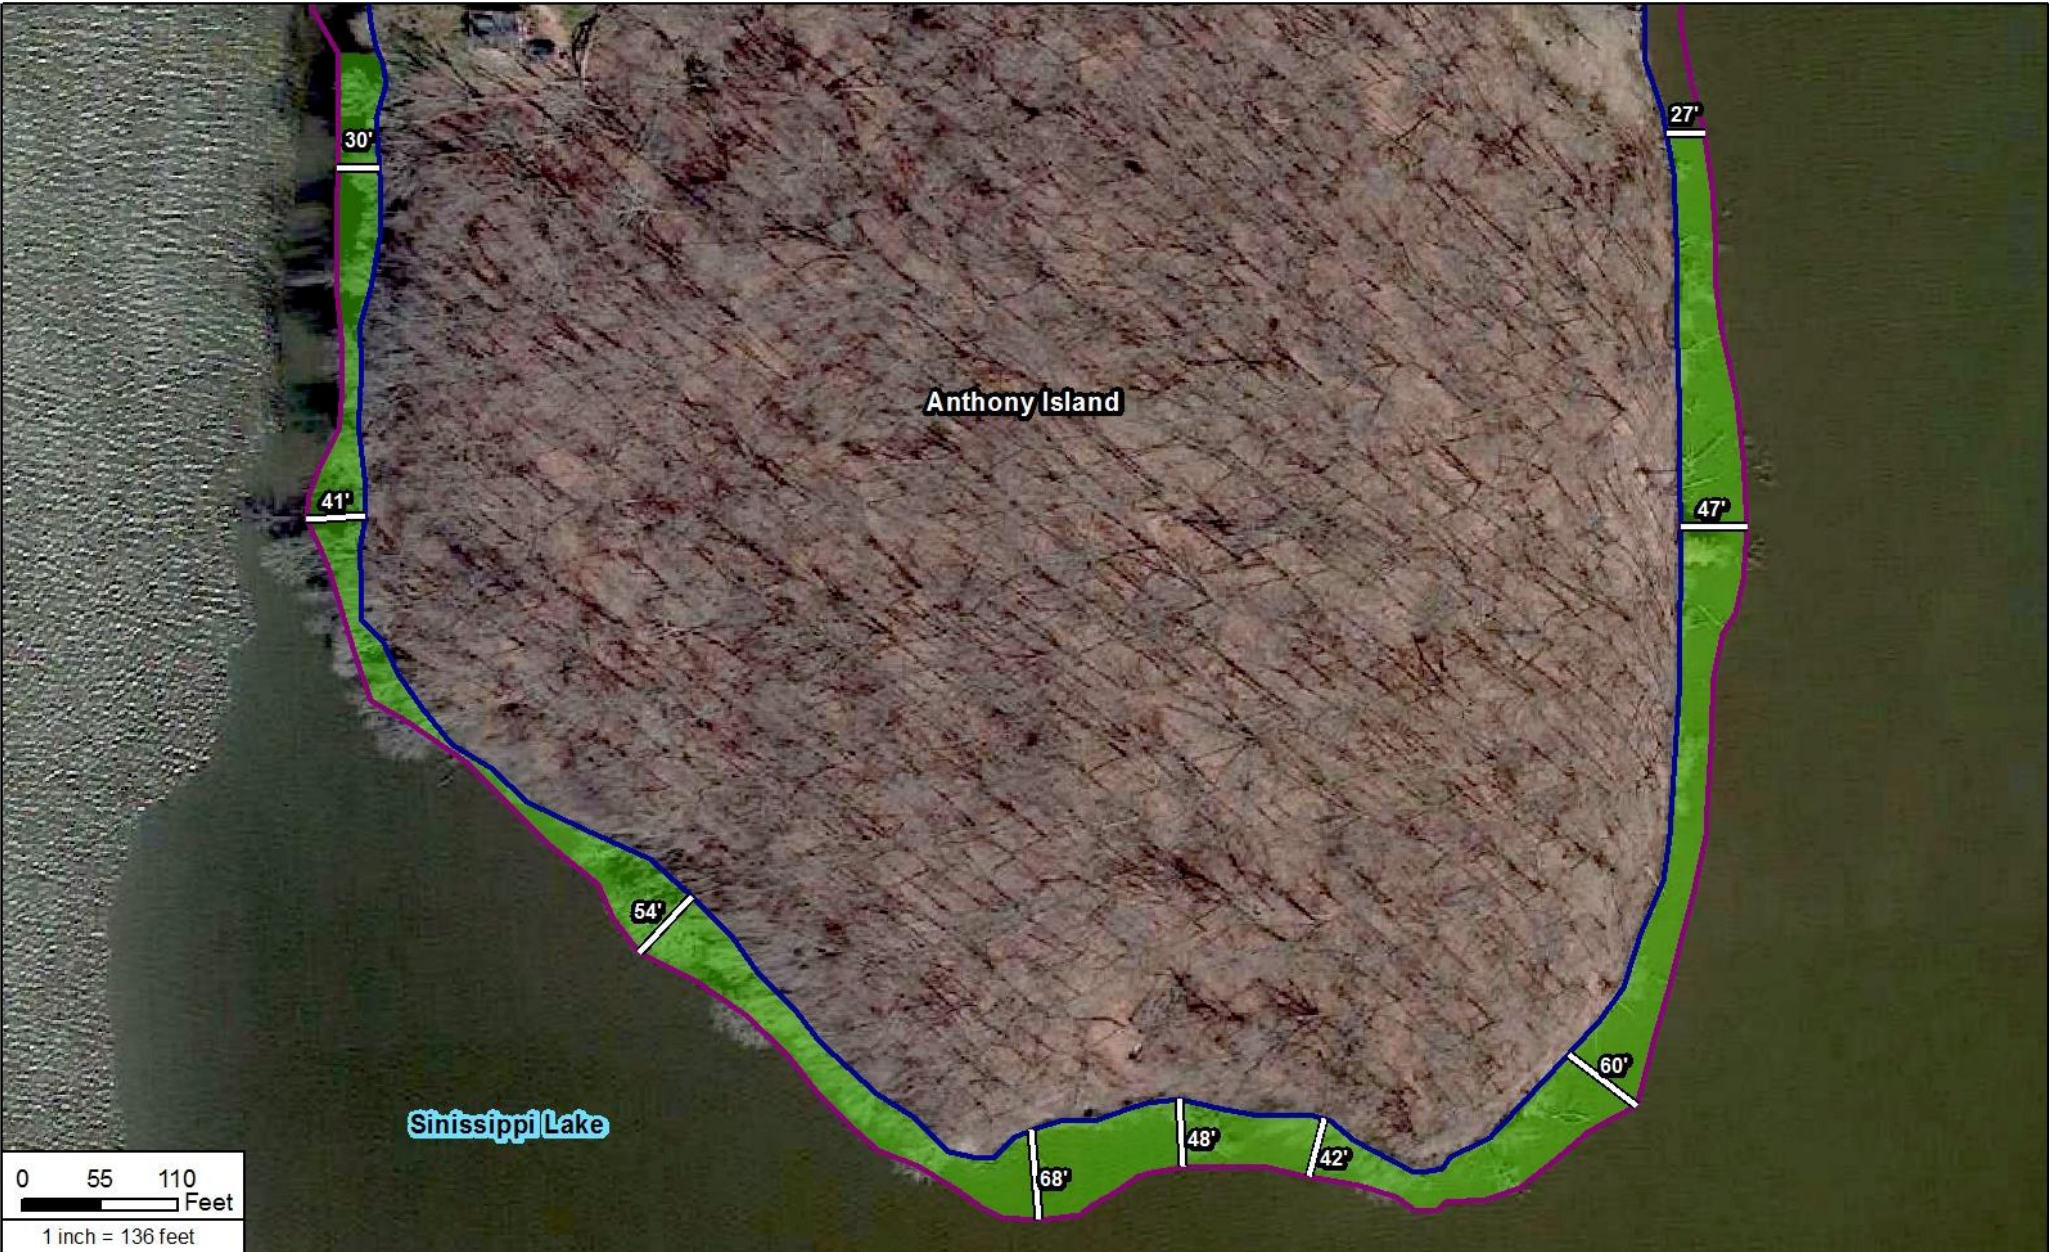
Figure 1. 1940 vs 2017 Shorelines  
Lake Sinissippi Impoundment District  
N5226 Wildcat Road  
Iron Ridge, Wisconsin 53035  
Section 09 T10N R16E  
Town of Hustisford, Dodge County

The consensus of LSID members is that Anthony Island, particularly the southern and western shorelines of the island have been receding at an accelerated pace. Based on aerial image comparisons from 1941 aerial imagery to modern times, the shoreline has receded anywhere from 30 to 60 feet (Appendix A, Figure 1). The LSID has elected to move towards a proactive solution to reduce shoreline recession and stabilize the shorelines with appropriate hard and/or soft armoring methods.

Shoreline Zone 2 (SZ-2) is the south-facing shoreline which lies between SRPs B and C. The total linear distance of SZ-2 is approximately 494 feet. Wave-generated shoreline erosion is relatively low here, mainly due to the geomorphology of the shoreline (shallow grade) and a shorter fetch, relative to other shoreline locations. Wave Energy calculations result in “Low Energy” due to the short fetch distance to the east shore (Appendix D). Wave erosion is reduced due to a shorter fetch as the distance to the south shore of the lake is less than 1,000 feet. However, SZ-2 has experienced anywhere from 42 to 68 feet of recession since 1941 (Figure 1), which is partially

through the drainage valley have resulted in a series of terraces upslope from the top of the bank. This continued process has resulted in a maximum of 54 feet of shoreline recession here since the 1940s (Figure 1).

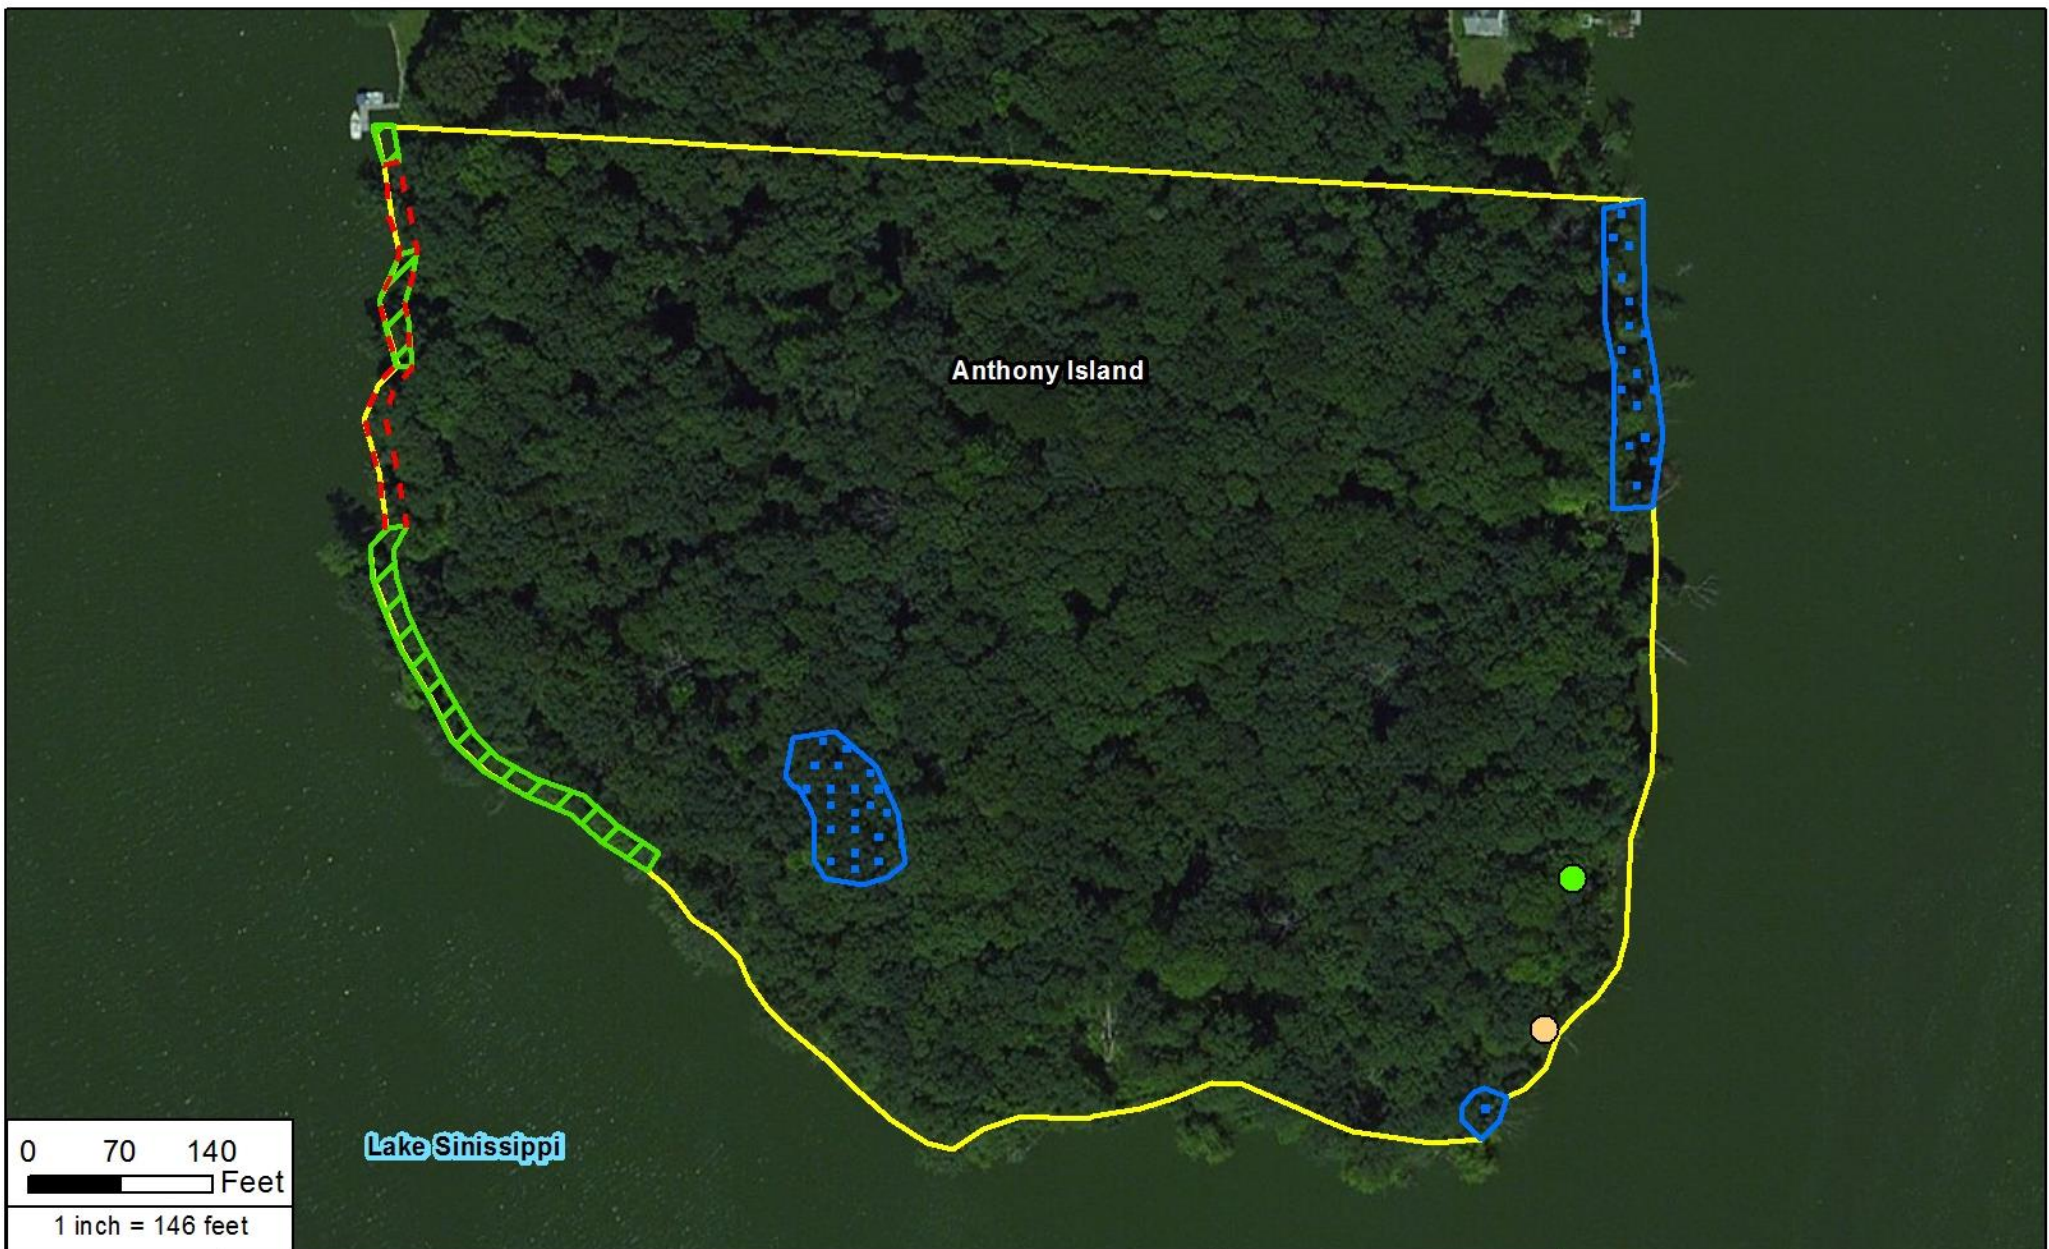
Figure 2. Invasive Species  
Lake Sinissippi Impoundment District  
N5226 Wildcat Road  
Iron Ridge, Wisconsin 53035  
Section 09 T10N R16E  
Town of Hustisford, Dodge County

Several small spatial areas of invasive species exist along the shoreline. These species include Asian honeysuckle (*Lonicera sp.*), common buckthorn (*Rhamnus cathartica*), black locust (*Robinia pseudoacacia*), Asian bittersweet (*Celastrus orbiculatus*), winged euonymus (*Euonymus alatus*), reed canary grass (*Phalaris arundinacea*), and purple loosestrife (*Lythrum salicaria*). Of these invasive species, Asian honeysuckle was the most prevalent and was found in numerous locations on the west and southwest shorelines. A clonal population of mature black locust is associated with the steepest bank area along Shoreline Zone 4. Remaining invasive species were found in isolated locations in relatively low density as indicated on Figure 2.

Vegetatively, the banks are mostly devoid of herbaceous vegetation, with some spatial areas of Pennsylvania sedge, common woodland sedge, and mosses overhanging the banks. Hardwood leaf litter is dense up to the crest of the bank. Woody vegetation in SZ-1 is primarily comprised of mature native trees, with a few select mature common buckthorn trees near the north end (SRP-A). Green ash, shagbark hickory, aspen, maple (silver, red, and sugar) and oak are common and tree roots are typically exposed and undermined at the bank. Most mature trees on the bank are leaning over the water. A significant amount of dead trees lie in the water, and numerous shoreline trees have dead or dying limbs overhanging the water. Native shrubs exist in clonal thickets periodically at the bank and further inland. Shrubs include American hazelnut, red osier dogwood, gray dogwood, nannyberry viburnum, and highbush cranberry. A single oriental bittersweet plant and a single winged euonymus plant was found (locations indicated on Figure 2).

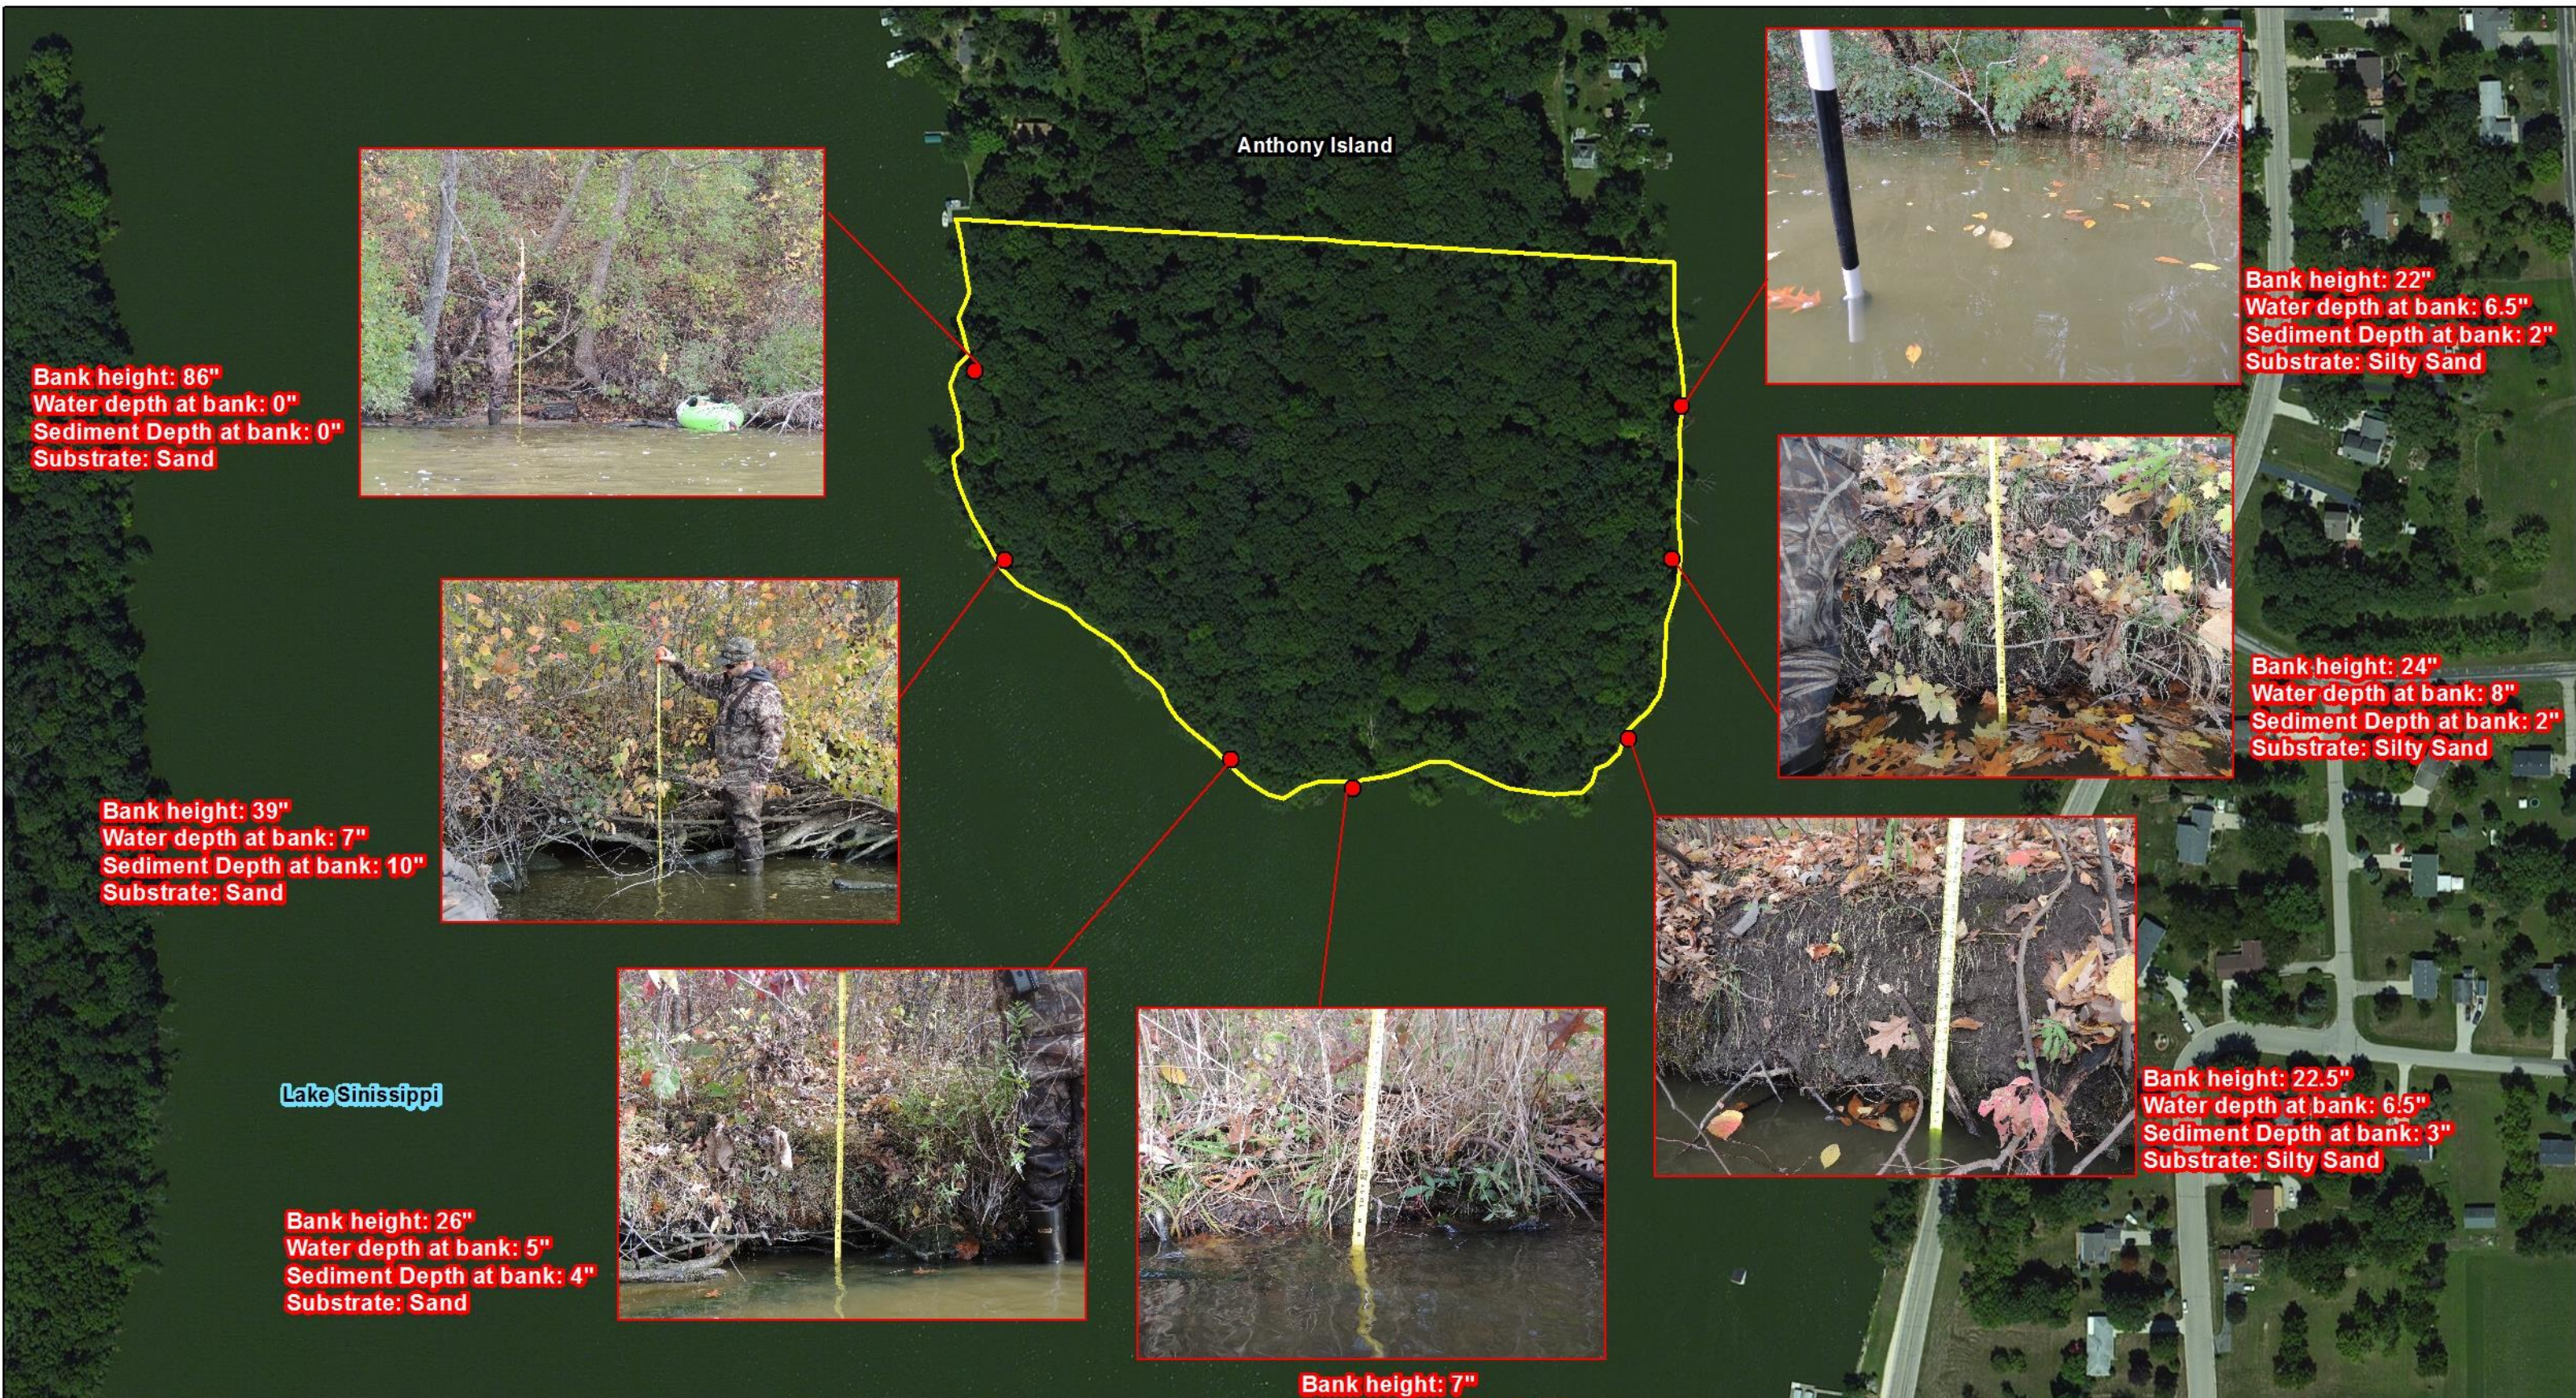
In most shoreline locations, tree and shrub root systems are the primary component maintaining structural integrity of the banks. Several species of native shrubs are prevalent on the shorelines, growing under canopy of mature deciduous trees in many locations. Shrub density is lower on the east shoreline (SZ-1) of the island as native trees exist along the east shoreline with higher density relative to other shoreline locations. Figure 3 indicates bank conditions along each Shoreline Zone.

**Bank height: 7"**  
**Water depth at bank: 7"**  
**Sediment Depth at bank: 5"**  
**Substrate: Sand**

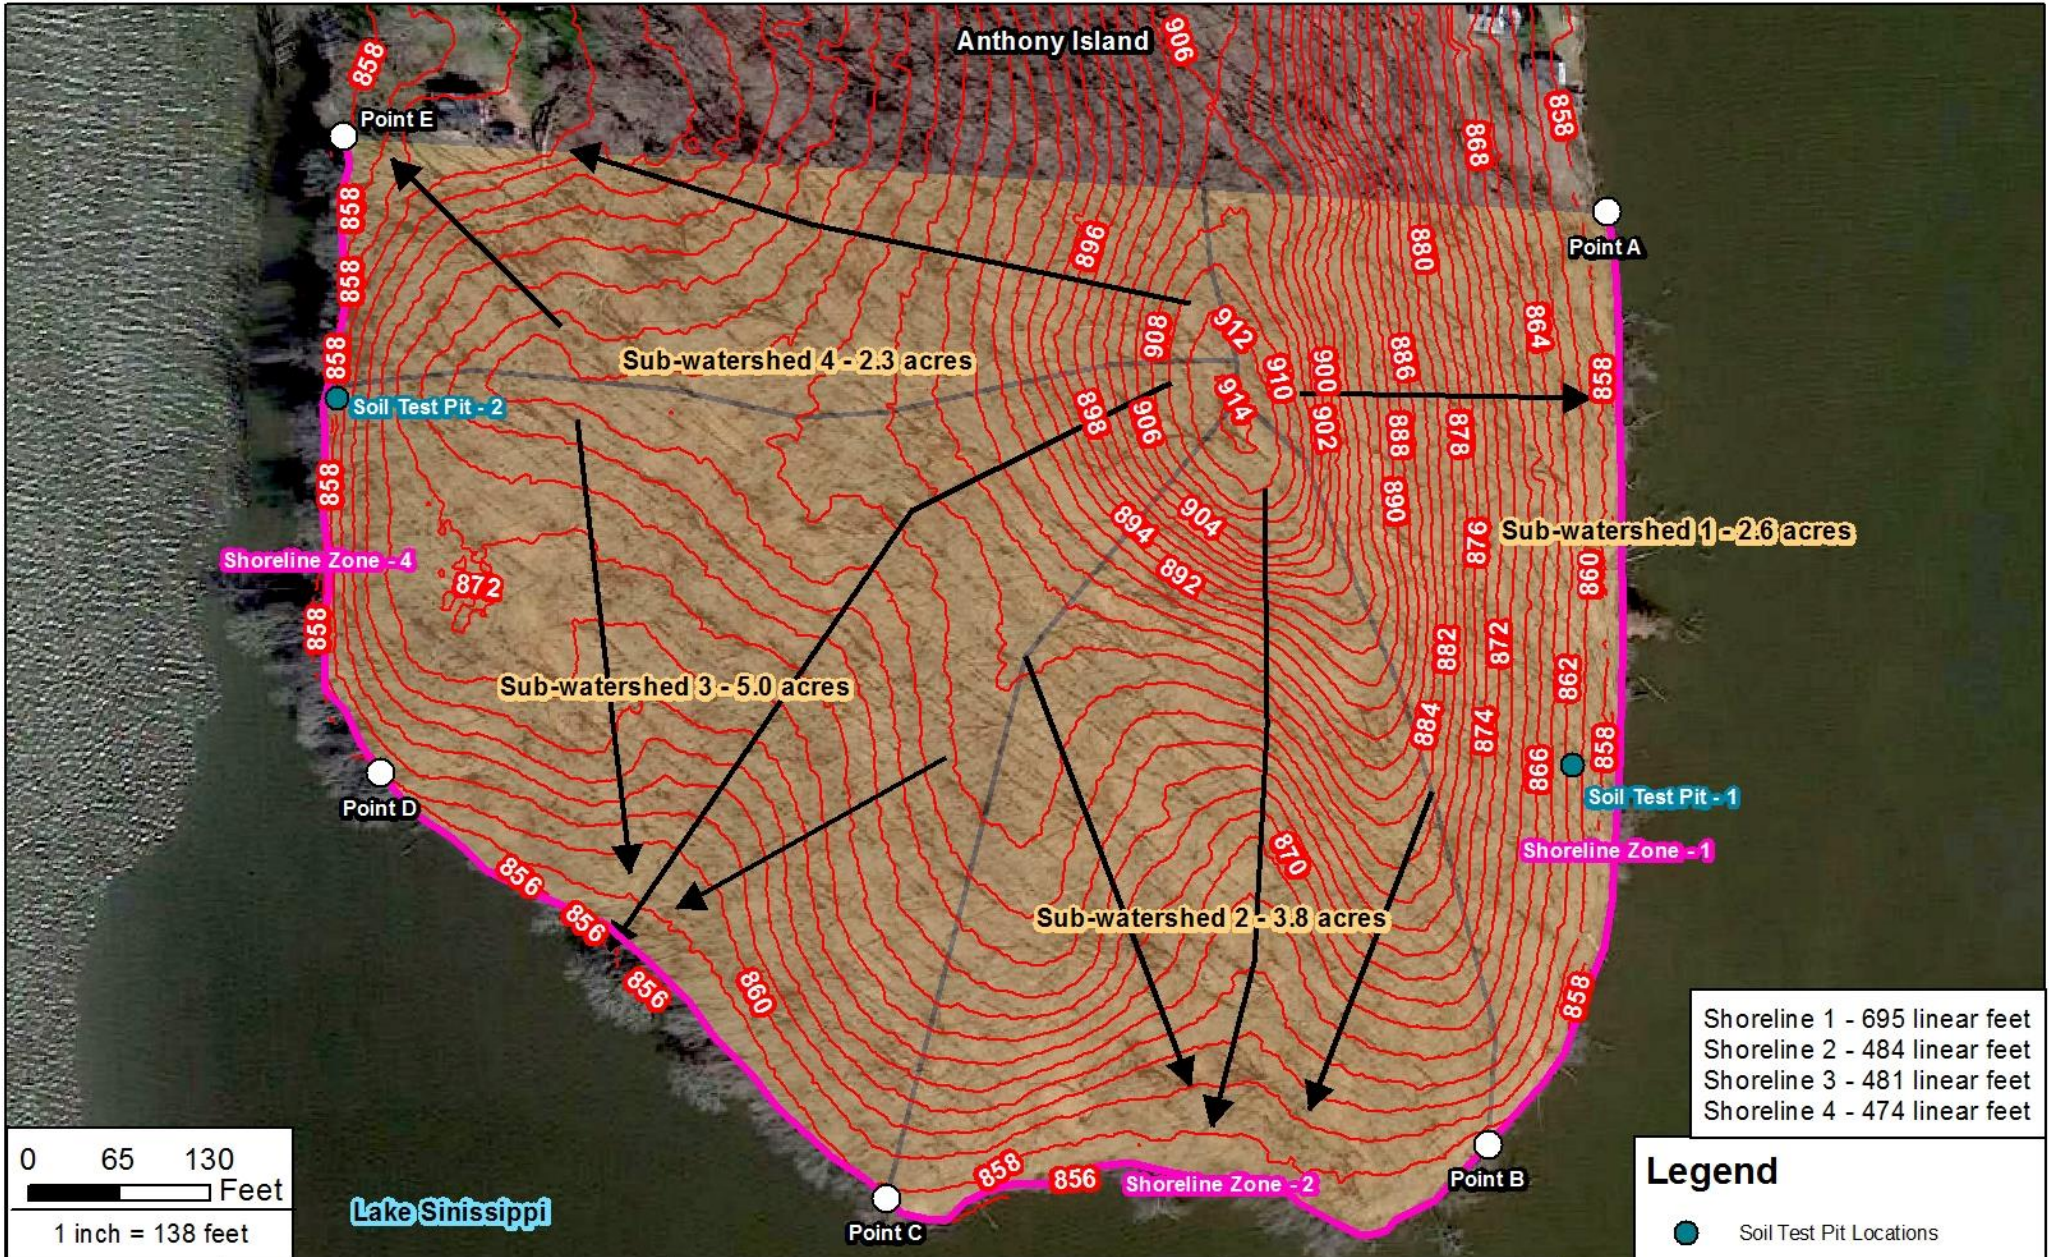
Figure 4. Drainage Patterns & Shoreline Zones  
 Lake Sinissippi Impoundment District  
 N5226 Wildcat Road  
 Iron Ridge, Wisconsin 53035  
 Section 09 T10N R16E  
 Town of Hustisford, Dodge County

Fifty-five feet of topographical relief exist on the south half of the island from the apex of the drumlin to the lake. With numerous ridges and valleys, four distinct sub-watersheds drain surface water to the lake (Figure 4).

Two soil test pits were advanced on opposite sides of the island. Each test pit was advanced within 10-20 feet of the top of the bank in upland position. Soil test pit locations are indicated on Figure 4.

Bank undermining and recession is the long-term process of soil loss primarily due to the erosional force of water scouring soil. In this case, wave action is the primary aspect of shoreline erosion. A secondary aspect of shoreline erosion is sloughing and undermining erosion because of stormwater overland flow through at least two distinct surface drainages on the island (Figure 4).

Shoreline 1 - 695 linear feet  
 Shoreline 2 - 484 linear feet  
 Shoreline 3 - 481 linear feet  
 Shoreline 4 - 474 linear feet

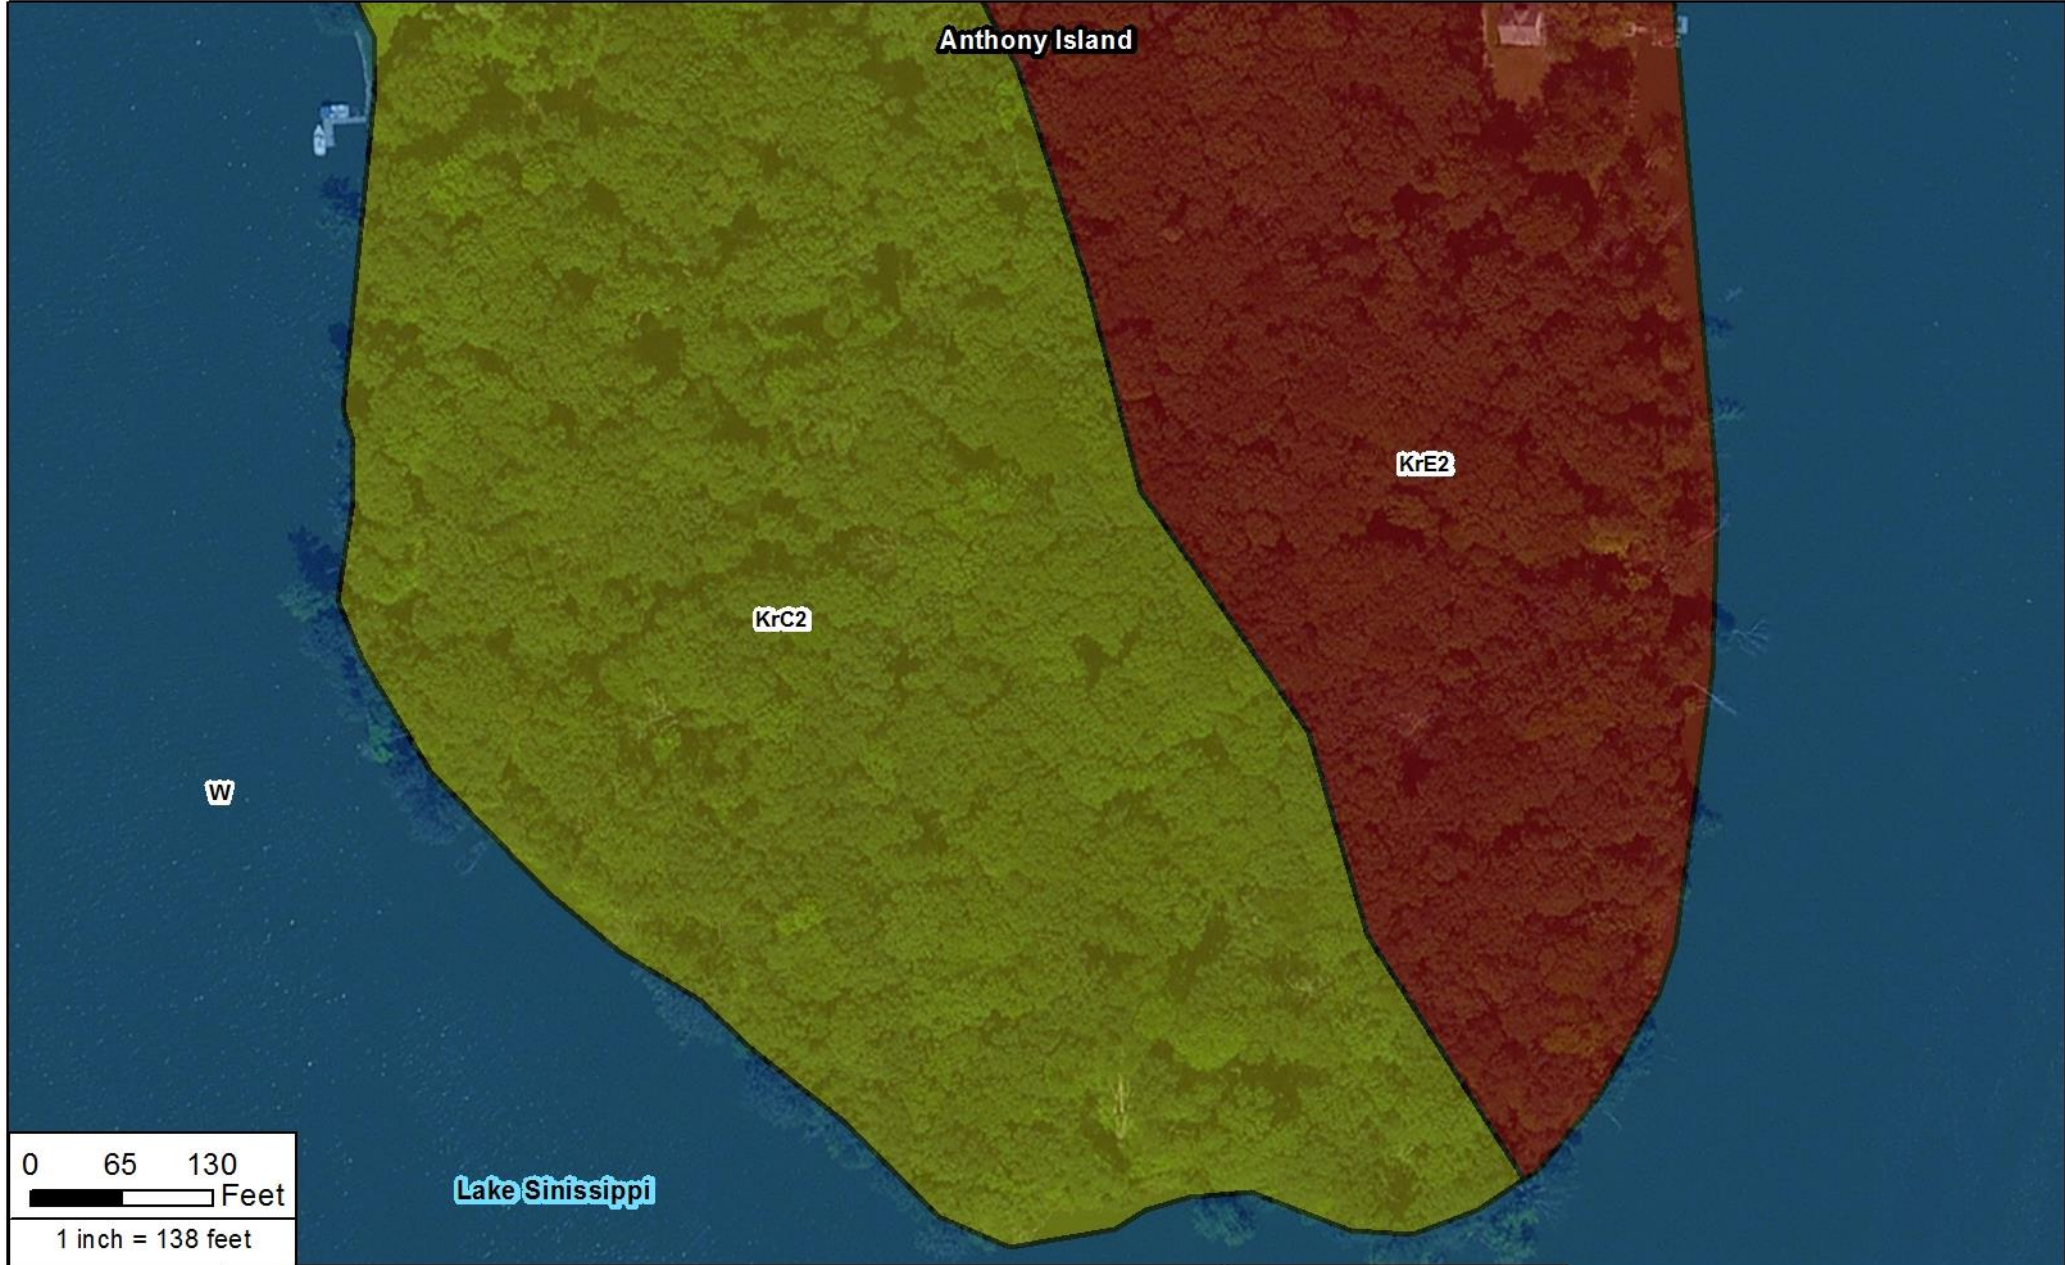
Figure 5. NRCS Web Soil Survey  
Lake Sinissippi Impoundment District  
N5226 Wildcat Road  
Iron Ridge, Wisconsin 53035  
Section 09 T10N R16E  
Town of Hustisford, Dodge County

Two soil types are mapped by the Natural Resource Conservation Service (NRCS) on the south half of the island, as indicated on Figure 5. The west half of the island is mapped as Kidder Loam, 6-12% slope, eroded. The east half of the island is mapped as Kidder Loam, 20-30% slope, eroded.

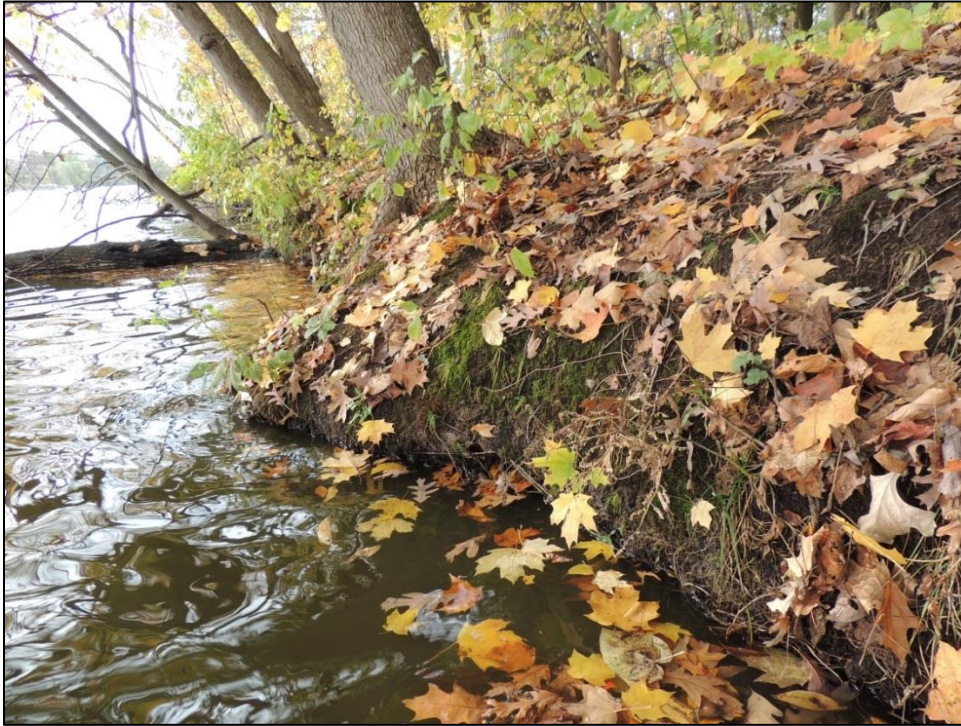
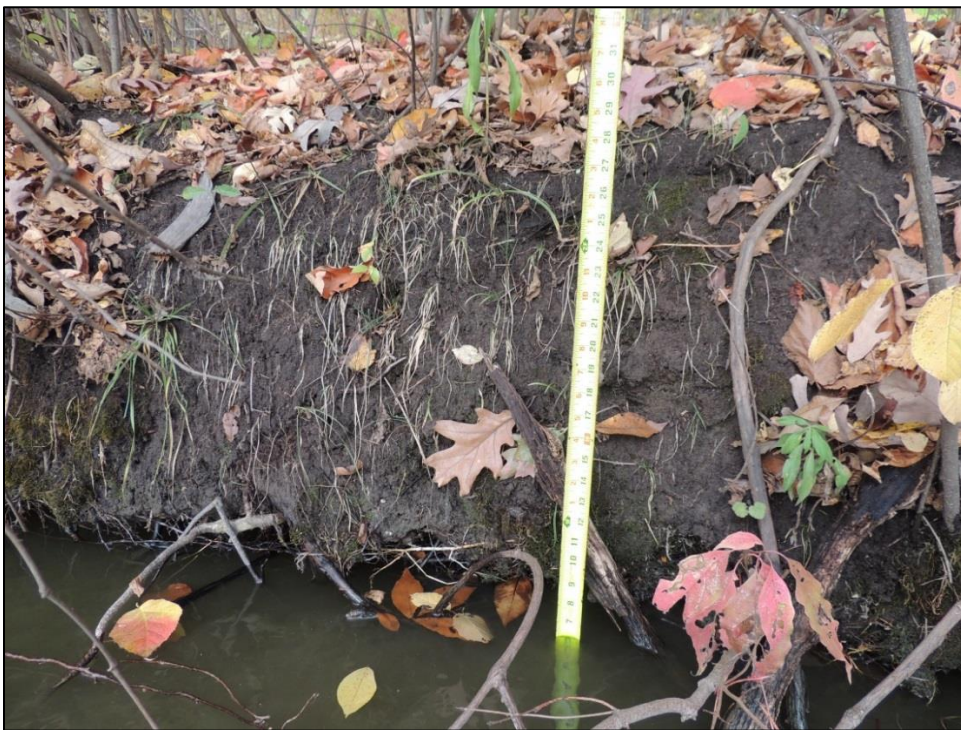
### Shoreline Zone 1

Shoreline Zone 1 (SZ-1) constitutes the entire east-facing shoreline of the south half of the island. SZ-1 lies between SRP-A and SRP-B and is approximately 702 feet in total linear distance. Bank heights range from 22 to 24 inches. A moderate level of shoreline erosion is occurring, primarily due to wave action. Overland flow is minimal due to a small relative watershed based on topography and drainage patterns (Figure 4). Banks are vertical and with water levels several inches below the Ordinary High Water Mark (OHWM), a moderate level of bank undermining is evident with 3-5 inches of undermining measured. Water depth at the bank ranged from 6.5 to 8 inches. Substrate at the bank consists of 2-3 inches of silty sand over a firm clay base. Wave Energy calculations result in “Low Energy” due to the short fetch distance to the east shore (Appendix C), however, boat generated wave energy is relatively high in this zone and is not considered with the WDNR’s Wave Energy Calculator.

Shoreline Zones 1 and 2 exhibit a reduced amount of bank erosion and a combination of bioengineered options will better suit these two shoreline zones. Wave erosion is reduced within these two zones due to a reduced fetch (compared to the west side); however, river flows and boat wake energy will continue to be erosive factors.

A combination of bioengineered soft armoring such as coir logs, brush bundles, live stakes, emergent plantings, and log-placement may be adequate and relatively inexpensive prescriptions for bank stabilization and restoration within Shoreline Zones 1 and 2 (Streambank and Shoreline Protection Manual).

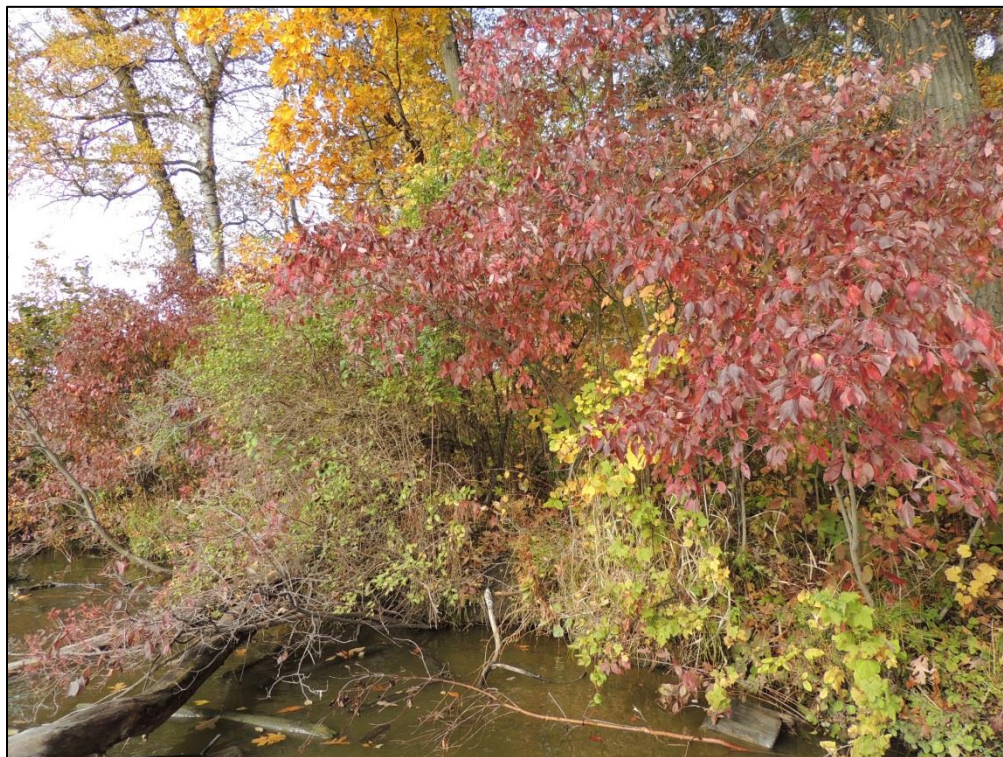
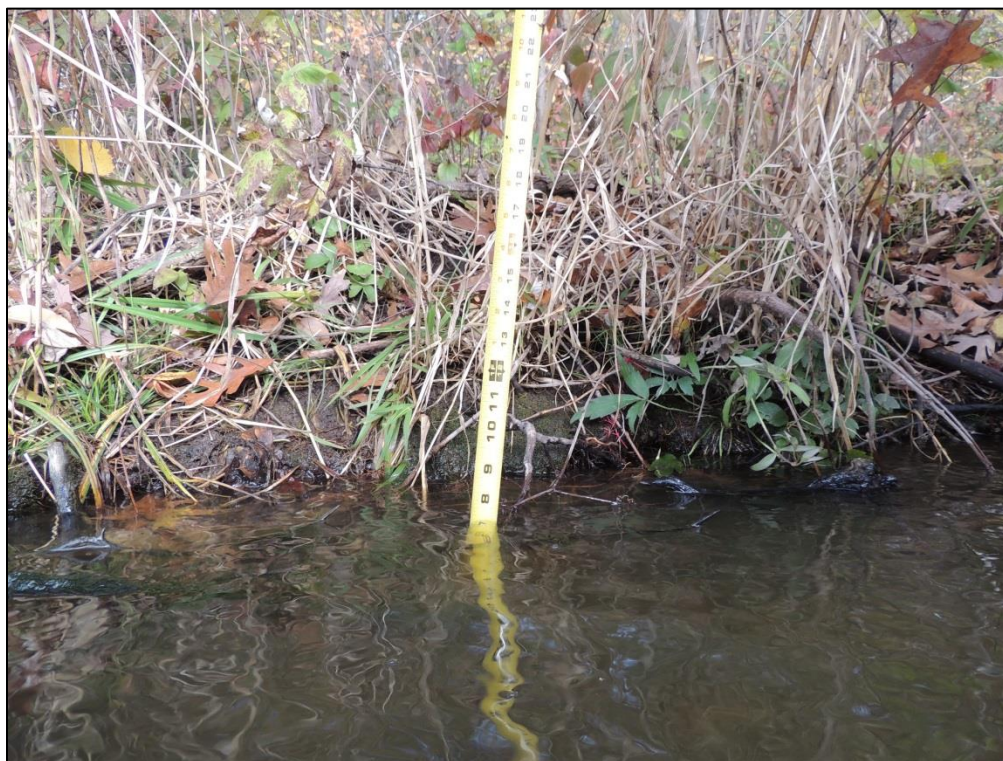
Shoreline Zone 2

This high rate of shoreline recession is primarily due to the concentrated drainage pattern based on topography and the largest sub-watershed within the south portion of the island. Over the last 75 years, overland stormwater flow erosion has back-cut the bank into a flat and shallow grade, creating a distinct scalloped bay. The bank heights within SZ-2 average only 7 inches which constitute the shortest bank heights of any other portion of the island. With short banks, undermining erosion on the banks is minimal. Substrate at the bank is mostly sand, which has eroded from the bank and shoreline area. Sand is also deposited here as river current slows and converges at the south tip of the island. Substrate depth averages 5 inches.

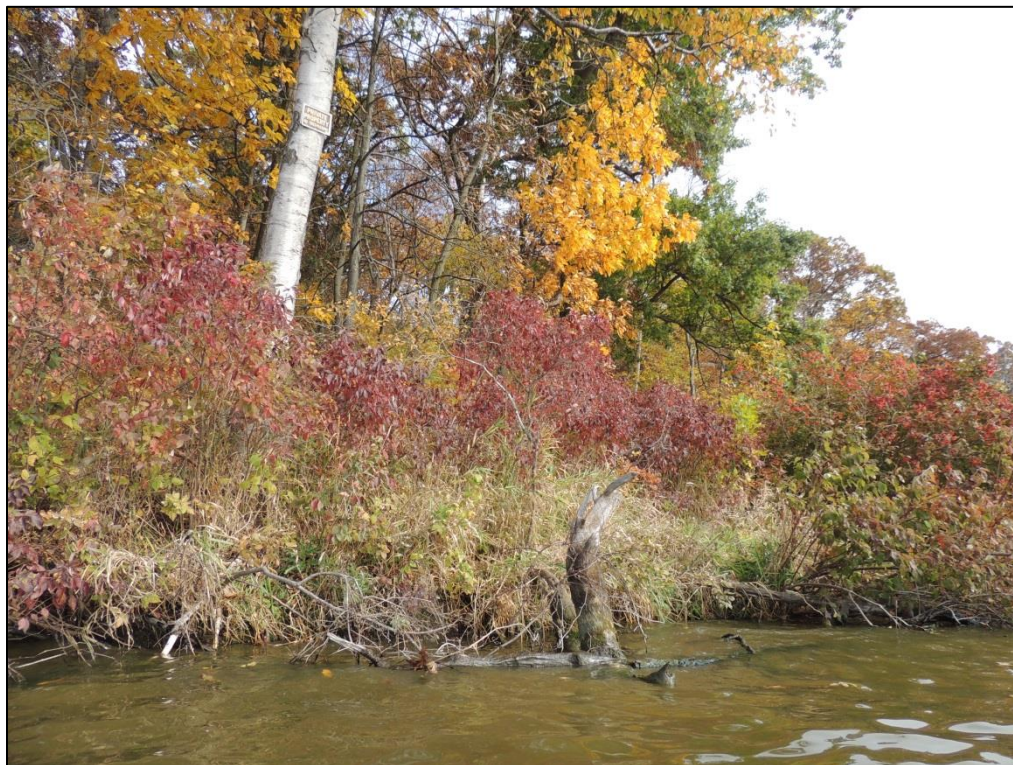
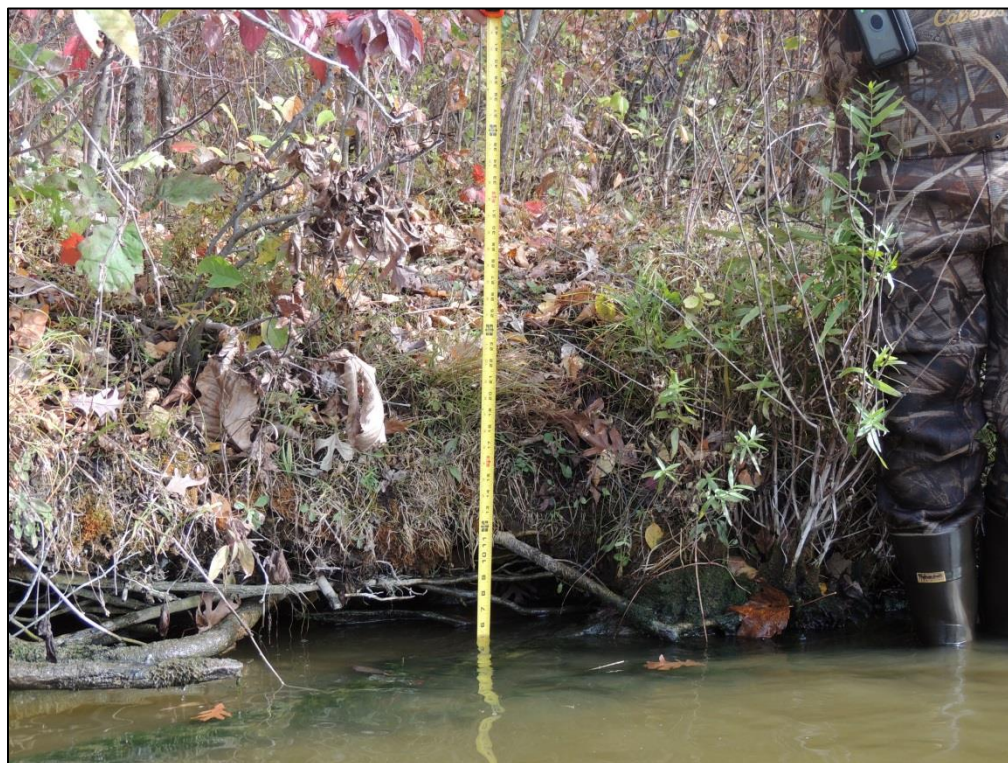
Shoreline Zone 3

Moving north from SRP-C, Shoreline Zone (SZ-3) lies between SRP-C and SRP-D. SZ-3 faces southwest and is approximately 479 linear feet. Shoreline erosion is occurring here which is a function of combined wave erosion and overland flow erosion leading to bank sloughing. The fetch distance to the south shoreline of the lake is just over 3,000 feet (Figure 6). But with water depths within this fetch area averaging only 5 feet, the shoreline wave energy is categorized as “Low Energy” (Appendix D).

The bank heights range from 26 to 39 inches, with a trend of increasing bank height moving north from SRP-C to SRP-D. Bank height reaches a maximum height of 39 inches at SRP-D. Bank undermining ranges from a few inches up to 20 inches within areas of dense root masses.

Overland flow erosion is a factor in bank erosion here as the sub-watershed that drains to the central point of SZ-3 is the largest on the island. Despite a mass of exposed twisted live and dead tree and shrub roots on the bank, undermining and back-cutting behind the roots has scoured the sandy soil and deposited the soil at the shoreline edge. Decades of sediment deposition

The recommendation for these two zones would be the installation of a large riprap revetment at the or near the existing bank along this stretch. The installation of riprap revetment would allow the primary causes of bank erosion to be focused lakeward of the current bank and allow for lakebed "replenishment" behind or landward of the revetment and establishment of emergent wetland restoration. The revetment would be at the approximate location of the former bank location in the 1940s (Figure 7) and would extend approximately 1,040 feet.

The proposed revetment would include installing large riprap (12-24") over a construction fabric that will support the riprap and reduce the rate of the riprap sinking into the lake sediments. This is a very common form of riprap installation and has a reasonable longevity. Erosion caused by ice action is frequently reduced by a nearshore ice barrier (Outhet 1974). This would allow the wave energy to be reduced before it reaches the existing bank during normal water levels, and during times of severe flooding, will cause the fine-grained sediments to settle out landward of the riprap. This type of revetment has been used on Lake Koshkonong, another reservoir on the Rock River in Jefferson County, Wisconsin.
