**LAKE SINISSIPPI IMPROVEMENT DISTRICT  
ANTHONY ISLAND SHORELINE AND NEAR-SHORE LAKEBED ASSESSMENT  
AND SHORELINE RESTORATION PLAN**

Eco-Resource Consulting, Inc.

January, 2018

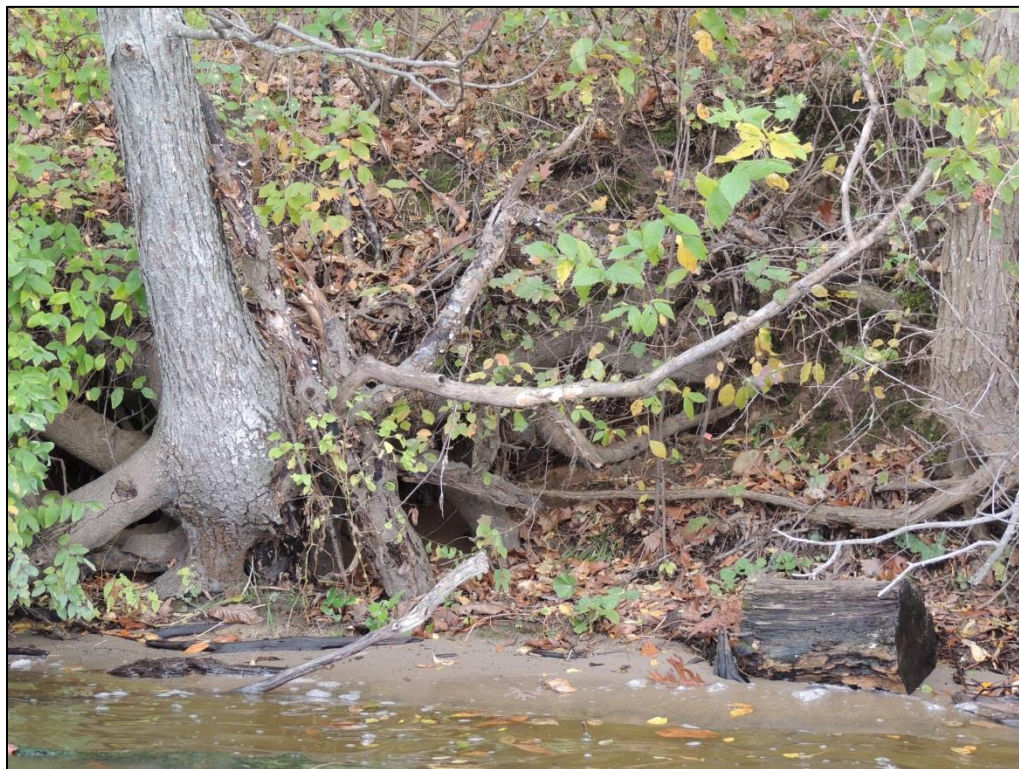
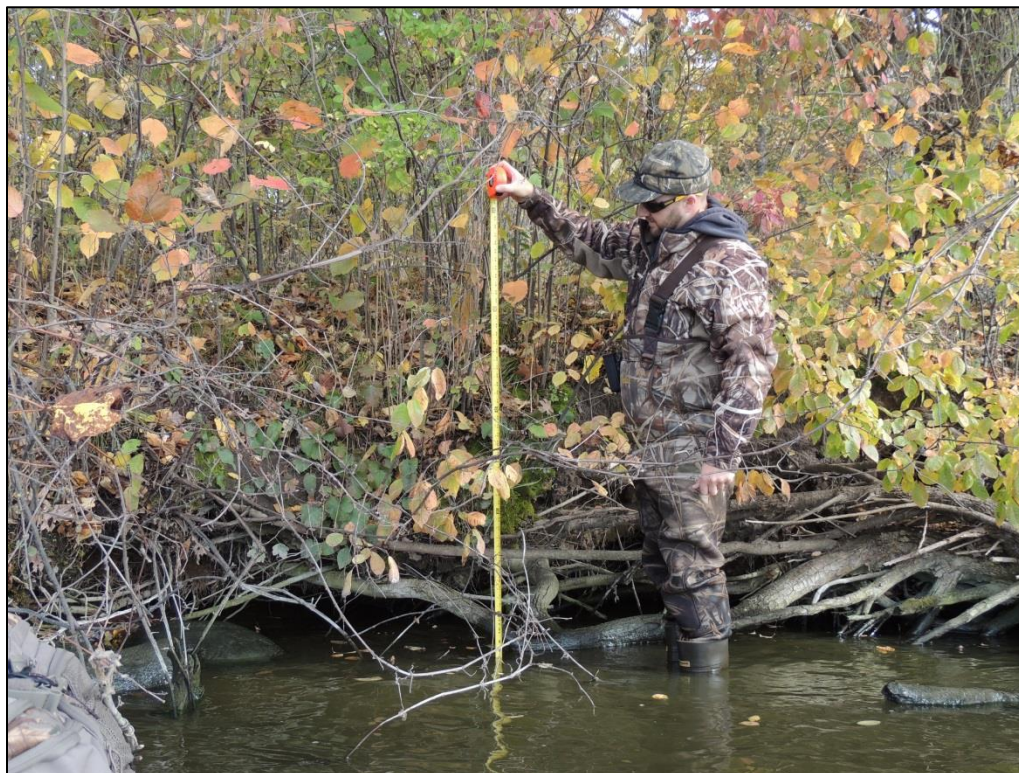
Shoreline Zone 4 (SZ-4) faces entirely west and lies between SRP-D and E. At 507 linear feet, SZ-4 is experiencing the least amount of overland surface water drainage, but the highest levels of wave erosion. The WDNR's Wave Energy Calculator results in a "Moderate Energy" category (Appendix E). This is due to the longest fetch distance of any location on the south half of the island, at more than two miles considering a northwest wind direction (Figure 6). Additionally, SZ-4 is straddled by two separate sub-watersheds, each directing overland flow towards the outer extents of the Shoreline Zone.

Bank heights are also higher than any other Shoreline Zone, with a maximum bank height of 86 inches (>7'). This tall bank height is primarily a function of shoreline geomorphology. Steep topography drops rapidly along most of SZ-4, with a gradual descent into shorter bank heights towards the northern end of SZ-4. As expected, the steepest bank height area is associated with the most severe shoreline erosion, with sloughing and bank undermining at high levels. Shoreline erosion is constant and most significant with SZ-4 and has resulted in a sandy bank in several locations. Some undermined areas behind tree and shrub roots extend several feet horizontally into the bank.

Vegetation at the south end of SZ-4 is dominated by native shrubs with periodic native deciduous tree overstory. Herbaceous vegetation is sparse and lacking. Trending north, as bank heights and shoreline erosional increase, native shrubs fade into invasive trees and shrubs. Near the area of tallest bank heights and steepest shoreline topography, a black locust clone exists at the top of the bank. This highly invasive tree species is thriving in highly disturbed well-drained soil conditions near the central portion of SZ-4. Asian bush honeysuckle also exists along SZ-4 in higher densities than any other shoreline location.

The recommendation for these two zones would be the installation of a large riprap revetment at the or near the existing bank along this stretch. The installation of riprap revetment would allow the primary causes of bank erosion to be focused lakeward of the current bank and allow for lakebed "replenishment" behind or landward of the revetment and establishment of emergent wetland restoration. The revetment would be at the approximate location of the former bank location in the 1940s (Figure 7) and would extend approximately 1,040 feet.

The proposed revetment would include installing large riprap (12-24") over a construction fabric that will support the riprap and reduce the rate of the riprap sinking into the lake sediments. This is a very common form of riprap installation and has a reasonable longevity. Erosion caused by ice action is frequently reduced by a nearshore ice barrier (Outhet 1974). This would allow the wave energy to be reduced before it reaches the existing bank during normal water levels, and during times of severe flooding, will cause the fine-grained sediments to settle out landward of the riprap. This type of revetment has been used on Lake Koshkonong, another reservoir on the Rock River in Jefferson County, Wisconsin.
