**Water Quality Monitoring and Assessment – Proposed Drainage District #88
Town of Burnett, Dodge County**

Report to the Dodge County Circuit Court

By the
Board of Commissioners
Lake Sinissippi Improvement District
Hustisford, WI
March 10, 2011

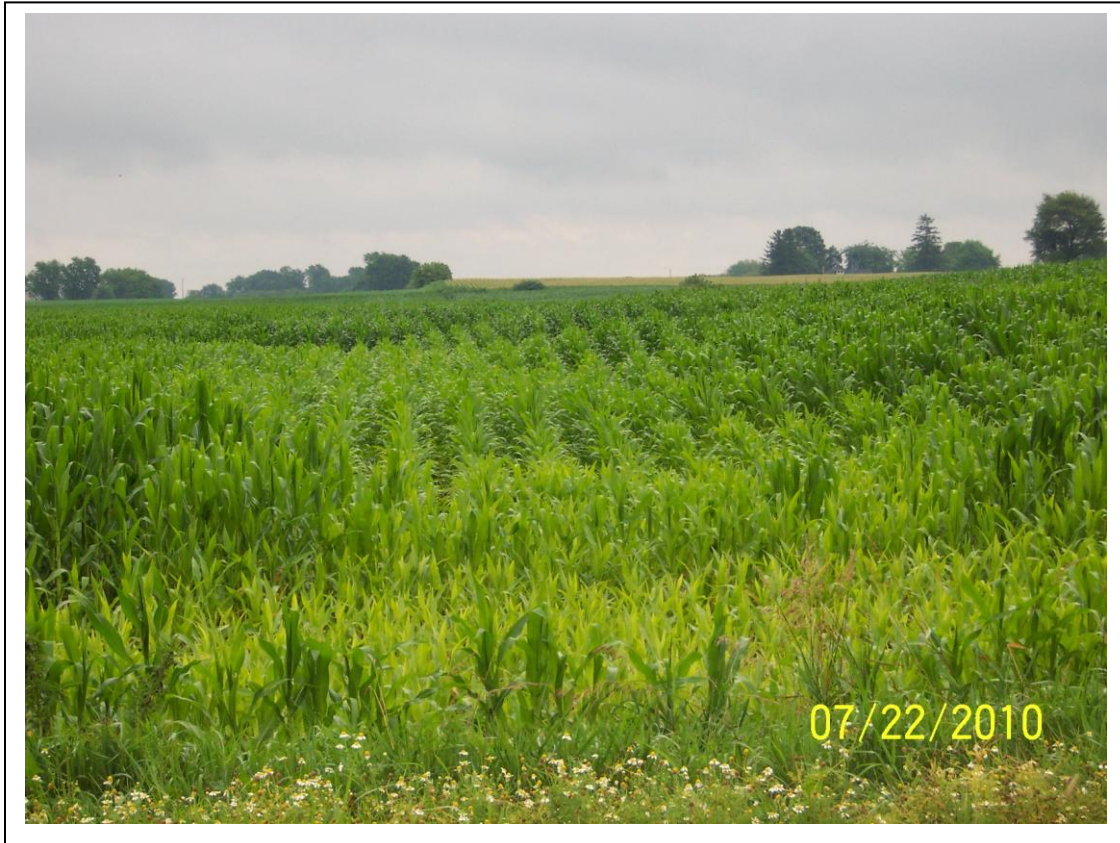
Comment: High concentrations of nitrogen compounds, phosphorus and total suspended solids were found in field runoff water at the Butternut Road culvert. Figure 1 shows that corn was planted directly in the field ditch that is to be part of the drain system of the proposed drainage district. This practice is in violation of state requirements for a drainage district, specifically §§ ATCP 48.24 and 48.30, that provide for minimum vegetative buffer corridors, prohibit row cropping in corridors and mandate measures to control erosion and runoff of suspended solids into district drains.

Figure 1. Field ditch at Butternut Road culvert, looking east. Corn is planted directly in the ditch that is to become part of the proposed drainage district drain system, a violation of state requirements as given in §§ ATCP 48.24 and 48.30.

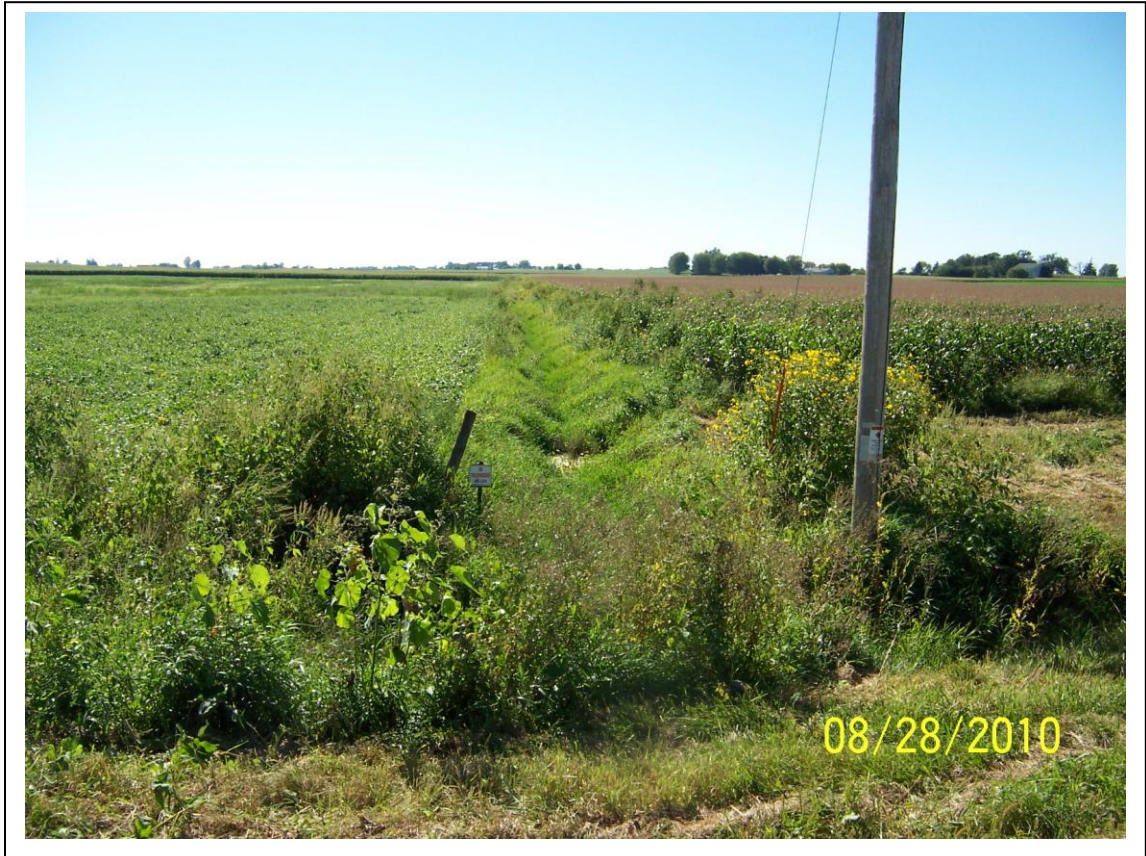
Comment: Elevated levels of nitrogen compounds, phosphorus, suspended solids, biochemical oxygen demand and fecal coliform were found at this sampling site. The high fecal coliform level may be a consequence of manure spreading by a dairy livestock operation west of this site. See Figures 2 and 3.

Figure 2. Existing field ditch at Road I culvert looking west. Agricultural field runoff from lands to the west, including those of the dairy livestock operation on Butternut Road, flows east in the drain ditch, through the culvert and then to the Dodge County Antique Power Club. This ditch is to become part of the district drain for the proposed Drainage District #88. The ditch appears to be in violation of state requirements given in §§ ATCP 48.24 and 48.30 that establish minimum 20-ft wide vegetative corridors on each side of a district drain, prohibit row cropping within ditch corridors and mandate erosion control measures to buffer against land uses that may adversely affect water quality in the ditch.

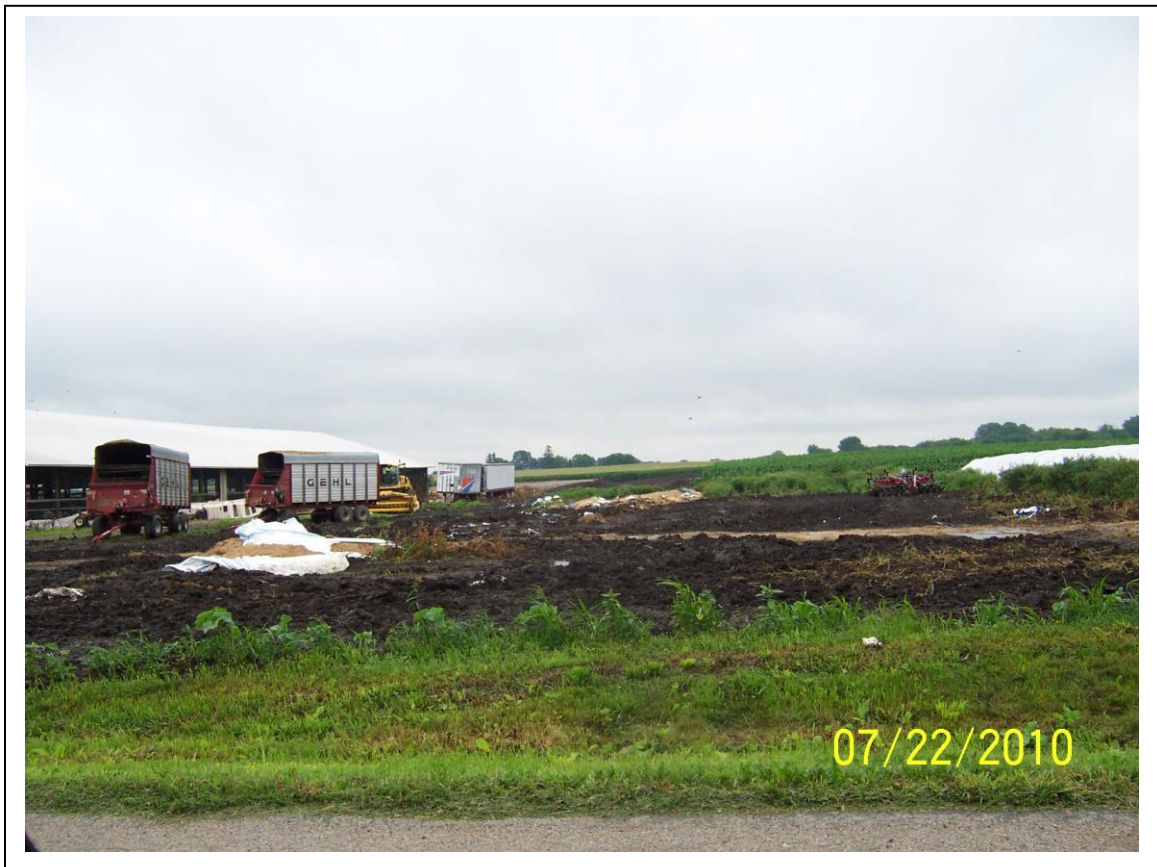
Figure 3. Dairy livestock operation located on Butternut Road, west of the sampling site at Road I. Photograph taken in the morning of July 22 prior to a major rain event.

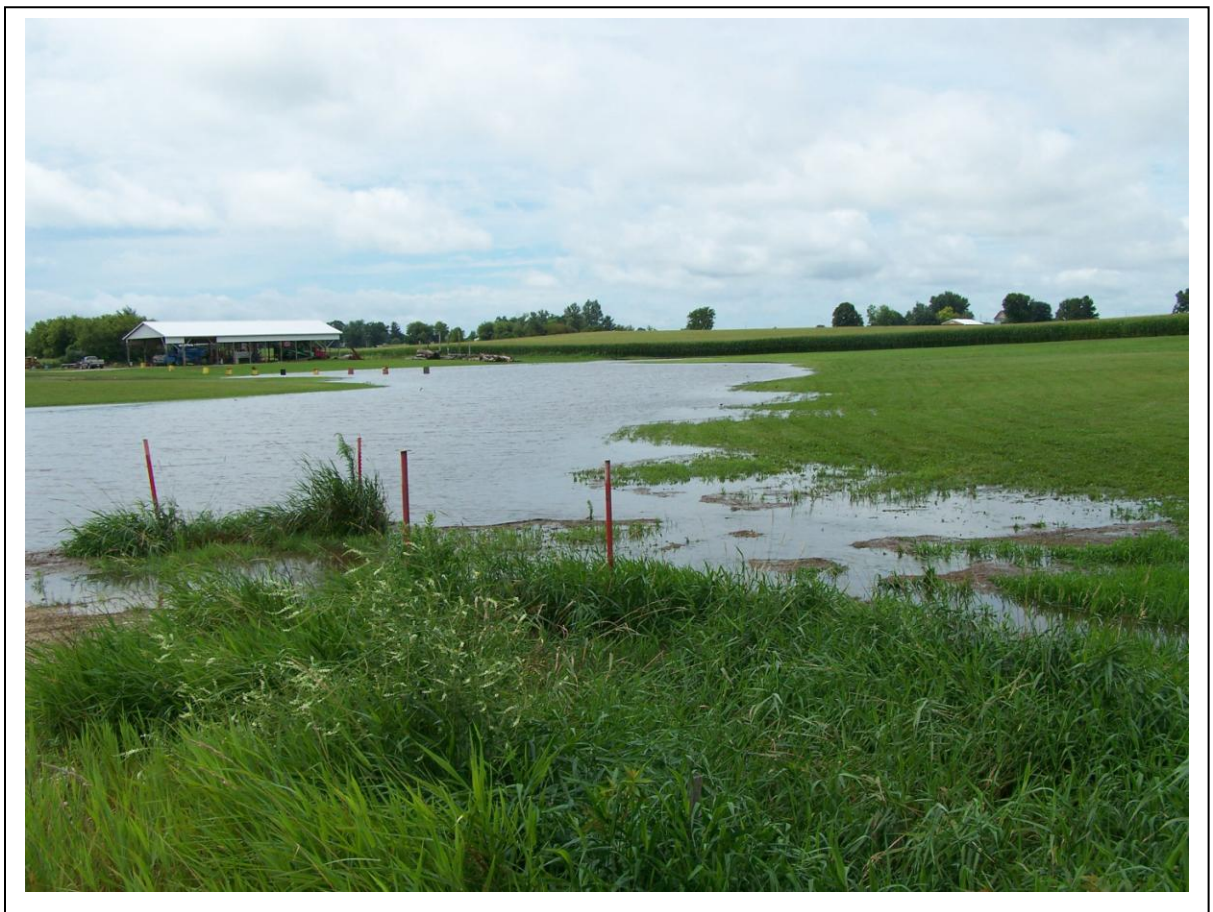
However, subsequent land filling during the late 1990s has rendered this area incapable of functioning as an infiltration basin, while ditching and tiling of farm fields to the west have increased the quantity of water flowing to the area during rain and snow melt events. Consequently, the subwatershed has become externally drained, with water from the drainage system moving overland and then channeled to pass through the road culvert at Highway B and into the soybean field to the north (see Figure 4). Pollutants in the drain water that exceed federal and state standards include nitrogen compounds, phosphorus and suspended solids.

Figure 4. Looking southwest across land owned by the Dodge County Antique Power Club. Agricultural field drain water flows onto this land from the west, then across the grassed area to become channeled and pass north through a road culvert at Highway B and into the Meylink soybean field. Photograph taken July 23, 2010.

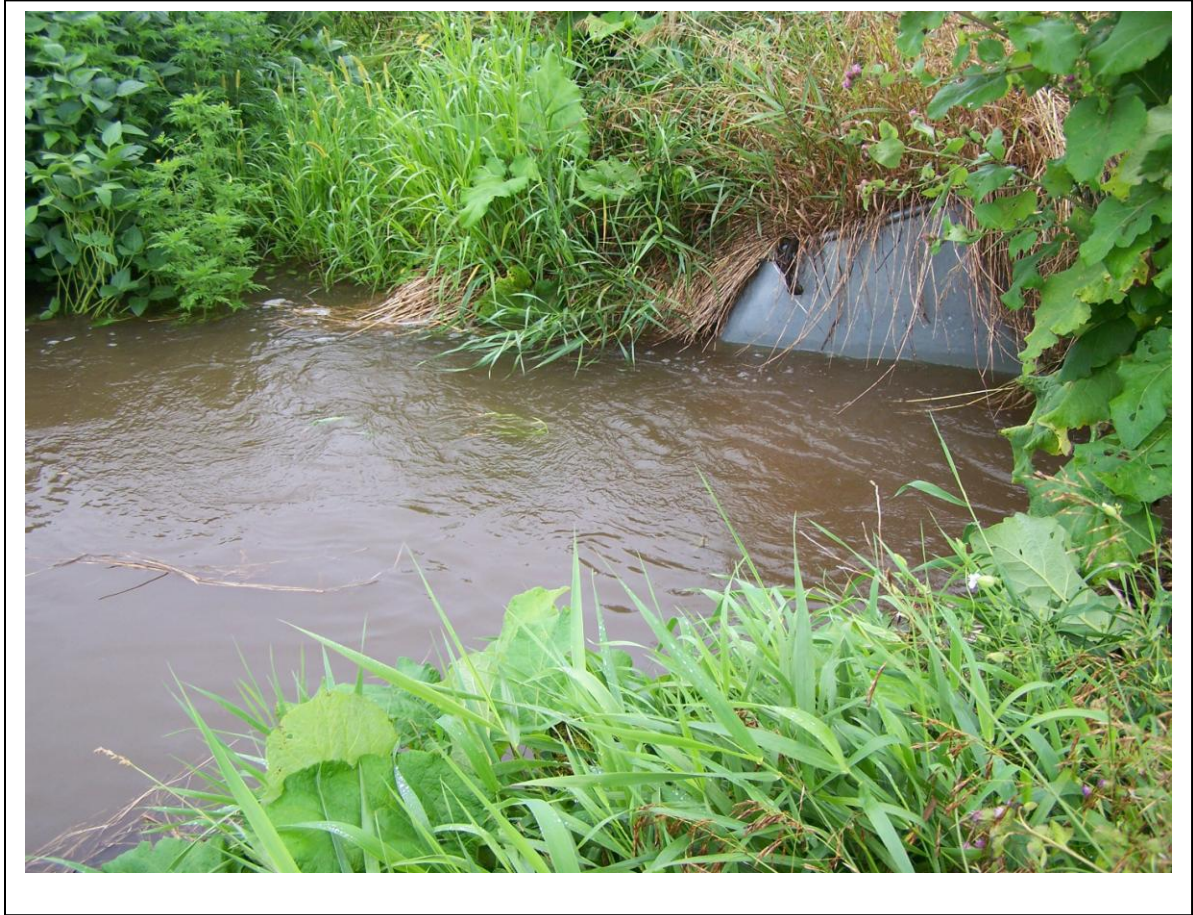
Field measurements and an estimate of drain water flow through the 42-inch culvert were made at 10:00 AM on July 23. Water flow covered about 60 % of the cross-sectional area of the culvert and the velocity of flow was estimated at 3 feet per second. $Q = V \times A$, where Q represents volumetric flow rate, V is average water velocity and A is cross-sectional area. Volumetric flow rate, Q, was about 20 cubic feet per second. This equates to an hourly flow rate of 72,000 ft³/hr, which is over 500,000 gallons of drain water per hour. A photograph of water flow through the culvert is shown in Figure 5.

Figure 5. Culvert underneath Highway B, carrying drain water from the Dodge County Antique Power Club north to the Meylink soybean field. The culvert is 42 inches in diameter with a cross-sectional area of 9.62 ft². At the time of measurement the water flow through the culvert was estimated at 20 ft³/s, equivalent to more than 500,000 gallons per hour. Photograph taken July 23, 2010.

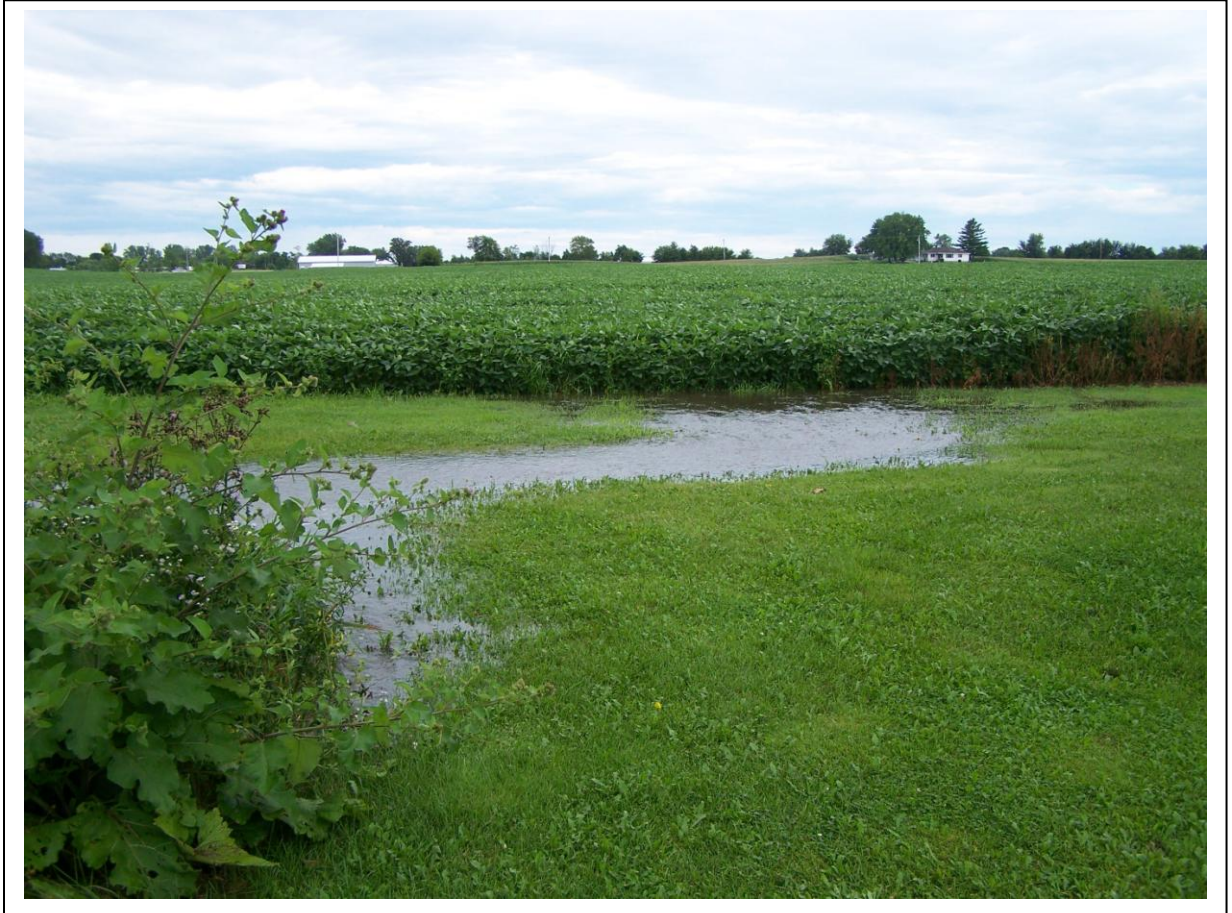
The channelized flow exiting the culvert passes into the soybean field where it joins drain water from the Wrock field drain and culvert, then exits the soybean field at the northern edge of the proposed drainage district and moves overland across a grassed area to empty into the spring-fed ponds and Spring Brook headwaters (see Figure 6).

Comment: These samples were taken from the overland water flow across the grassed area shown in Figure 6 on July 23, 2010, at the end of a major rain event. Values for nitrogen, phosphorus and total suspended solids exceed federal reference conditions and state standards for these parameters. This overland flow of field runoff and drain water from the Meylink soybean field goes directly to the first of several spring-fed ponds that are the headwaters of Spring Brook creek (see Figure 7).

Figure 6. Looking south from the west gate of Spring Brook Farm to the Meylink soybean field that lies on the northern edge of the proposed drainage district. Agricultural field runoff and drain water is flowing from the soybean field over a mowed grass area to the vegetated section at the left of the photograph, then into the first of several spring-fed ponds that comprise the headwaters of Spring Brook. Photograph taken the morning of July 23, 2010, near the end of a rain event that recorded 2.53 inches of rainfall.

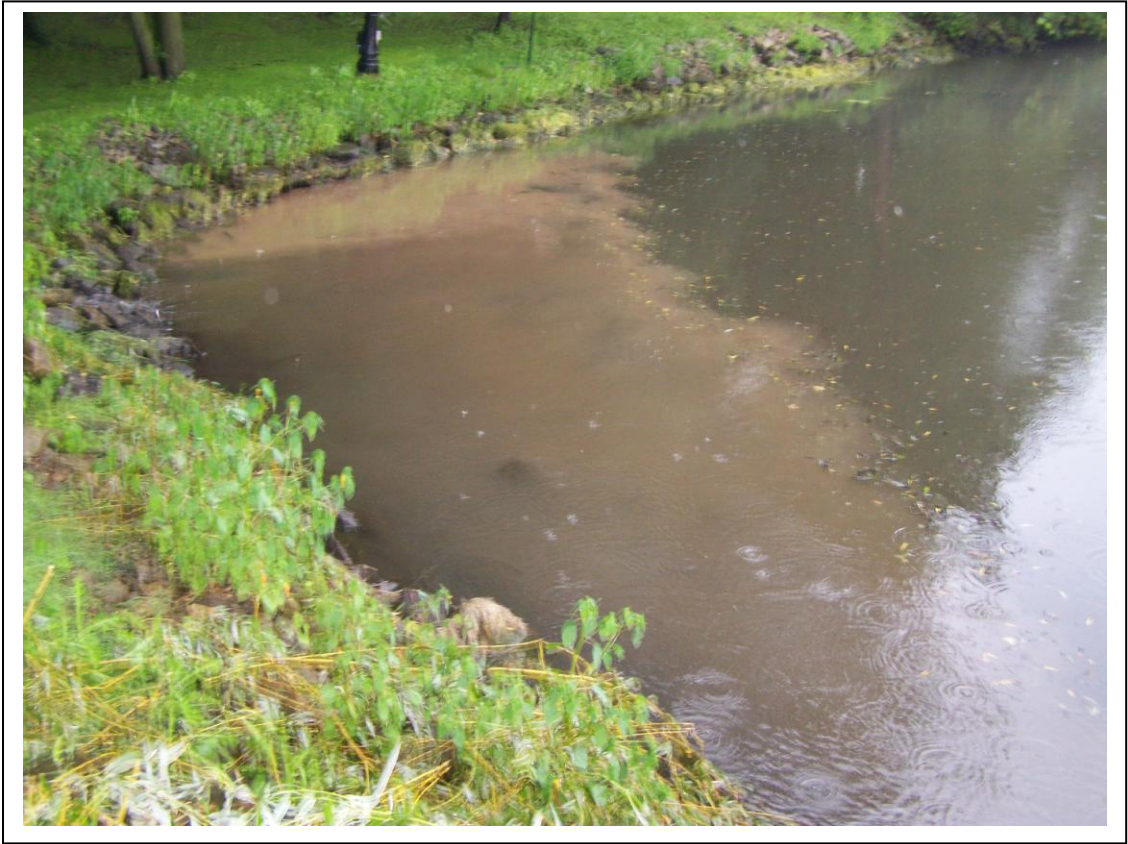
Figure 7. The first of the spring ponds that receives sediment and other pollutants from the agricultural field runoff flowing from the soybean field located within the proposed drainage district. Photograph taken early July 23, 2010 during a rain event.

Based on measurements taken by the farm owners, water depth of the ponds has decreased about 2 feet over the past decade due to sedimentation of silt and clay particles and organic solids washed into the ponds from the surface runoff from the agricultural fields.

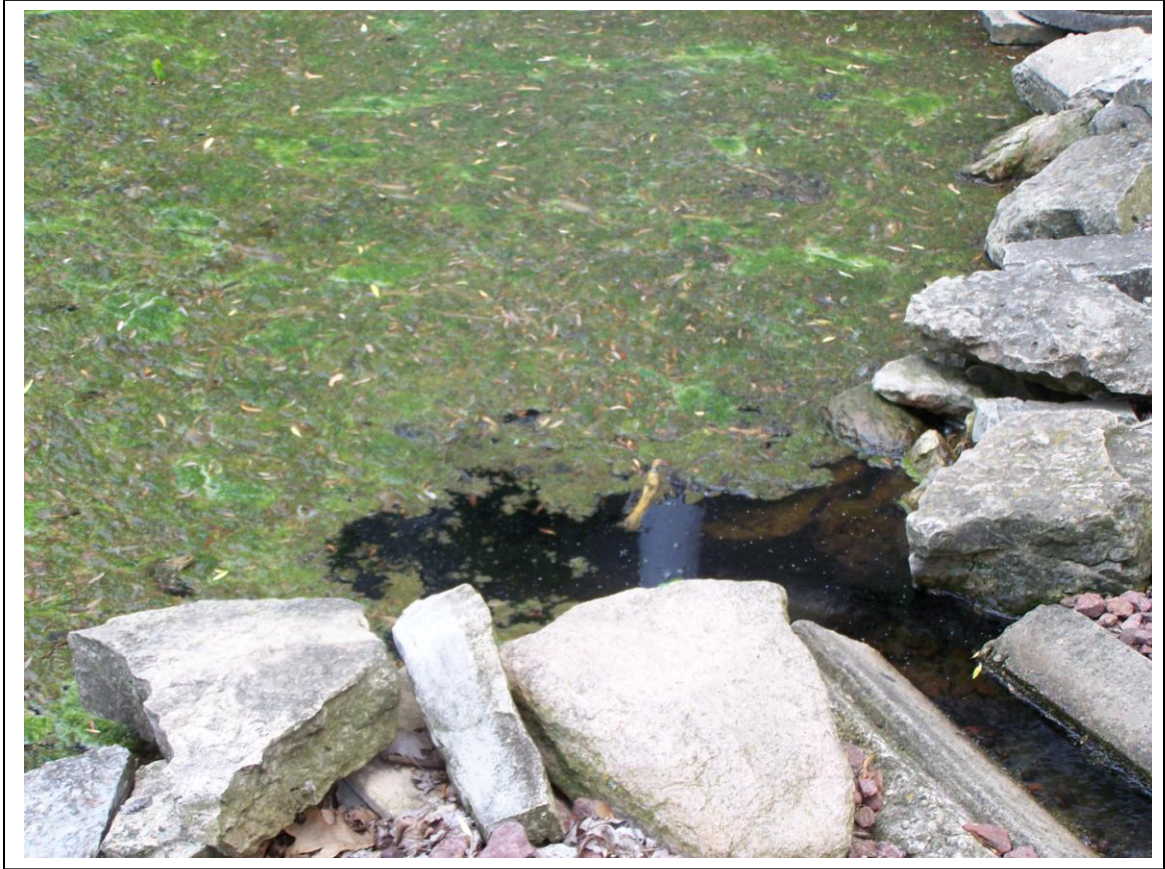
Elevated levels of phosphorus and nitrogen compounds in the ponds contribute to summer algae blooms, which were quite evident during the sampling trips the end of July. High algae concentrations often result in a significant decrease in dissolved oxygen content during over-night respiration, and when the algae die and decompose, oxygen in the water is depleted (see Figure 8).

Figure 8. Algae growth on surface of a spring-fed pond located at Spring Brook Farm. The concrete channel at the lower right of the picture conveys spring source water to the pond. Photograph taken May 24, 2010.

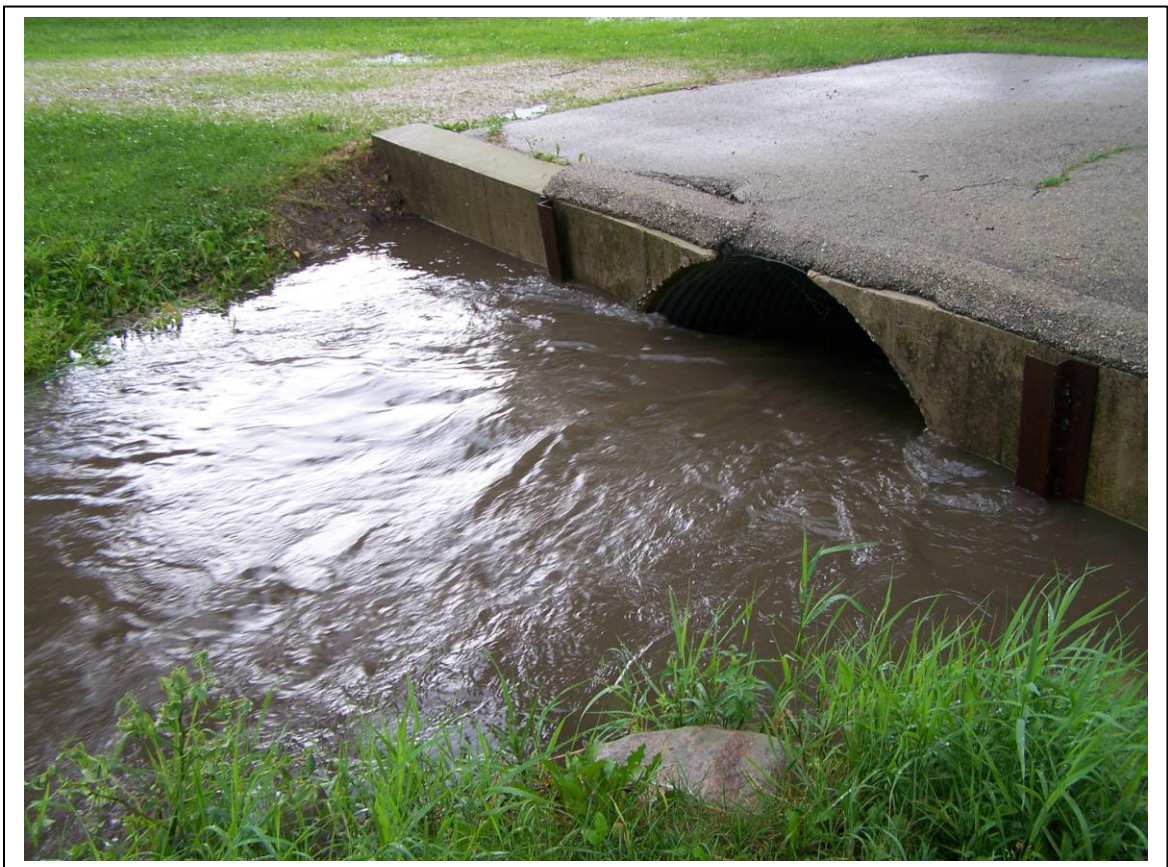
Figure 9. Photograph taken July 22, 2010 of Spring Brook flowing through a 6 x 4-ft culvert at Fireman’s Park, Burnett, during a rain event. The water flow of the creek is within 10 inches of over-topping the culvert. On either side of the culvert and bolted to the concrete structure are metal channels for stop logs. The stoplog dam is designed to adjust water level and reduce flow downstream to the community. However, during high-water conditions, such as existed during this rain event, the dam is ineffective in controlling flow and flooding occurs, as is shown in Figure 10.

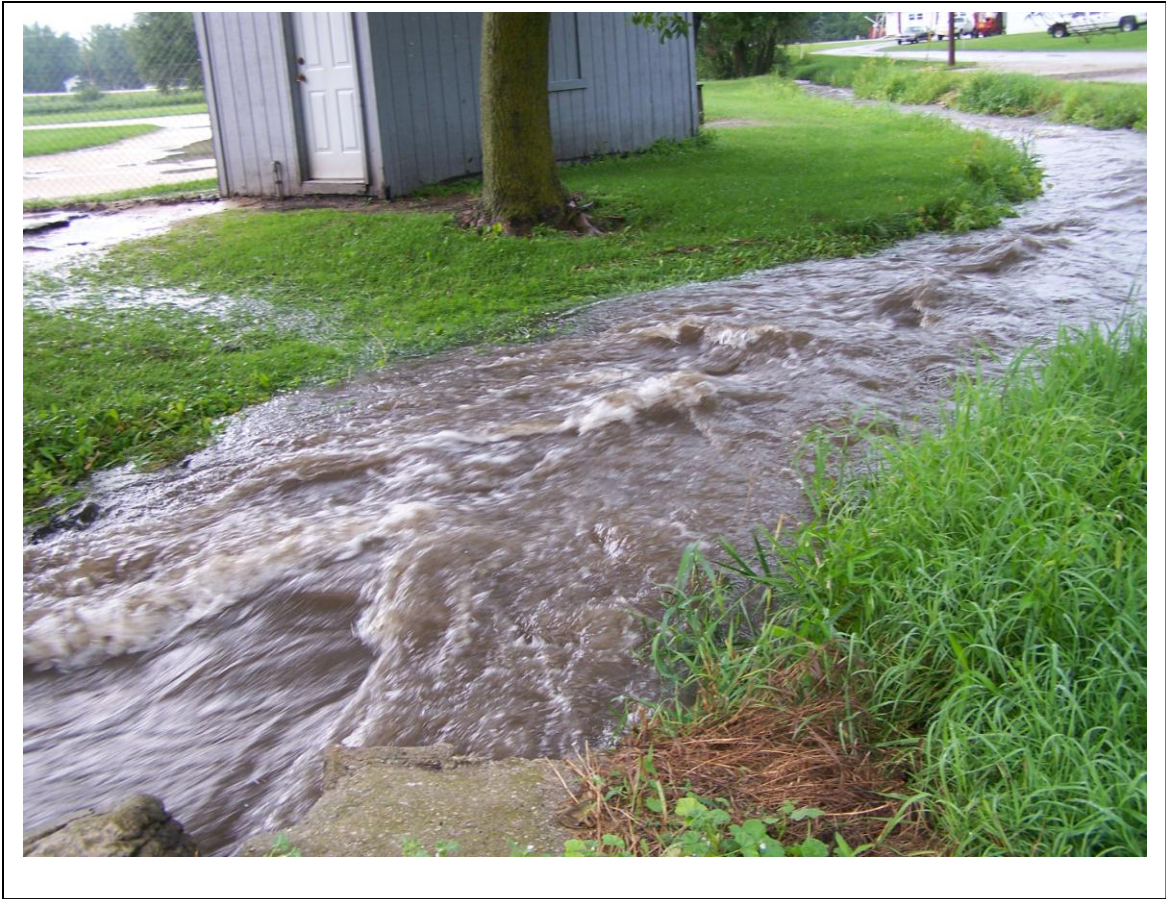
Figure 10. Photograph taken July 22, 2010 of Spring Brook flowing from the culvert at Fireman's Park, Burnett, during a rain event. In the region of turbulence just downstream of the culvert, the creek has overtopped the north bank. A representative of the Burnett Sanitary District testified at the drainage board public hearing on July 13, 2010 and expressed concern about the increased quantity of surface water flowing to the community if the proposed drainage district is established.
