CONCEPTUAL DESIGN REPORT

ROCK RIVER CHANNEL WATERWAY IMPROVEMENT PROJECT

Stantec Project #: 193702335
March 14, 2014

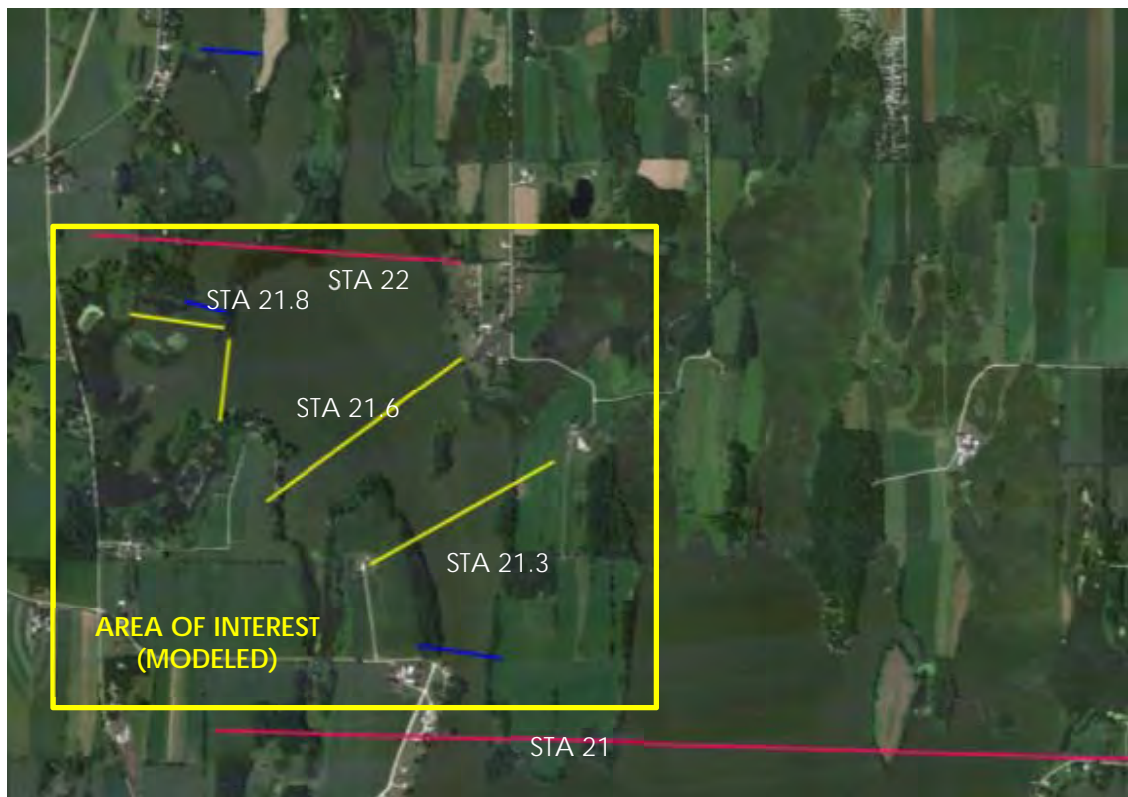
Drawing 1 – LOCATION OF CROSS SECTION DATA

Using the previously developed HEC-RAS model to establish the overriding hydraulic context, additional conveyance cross section data (collected during geomorphic assessment) was evaluated. The CTH S culvert was determined to be non-material to flow dynamics in the project area. The various cross sectional data was inserted into the model geometry (Drawing 1). The flow conditions were modified to reflect uniform flow (as opposed to the previous gradually varied flow) and the boundary conditions adjusted to normal depth upstream and critical depth over the dam downstream.

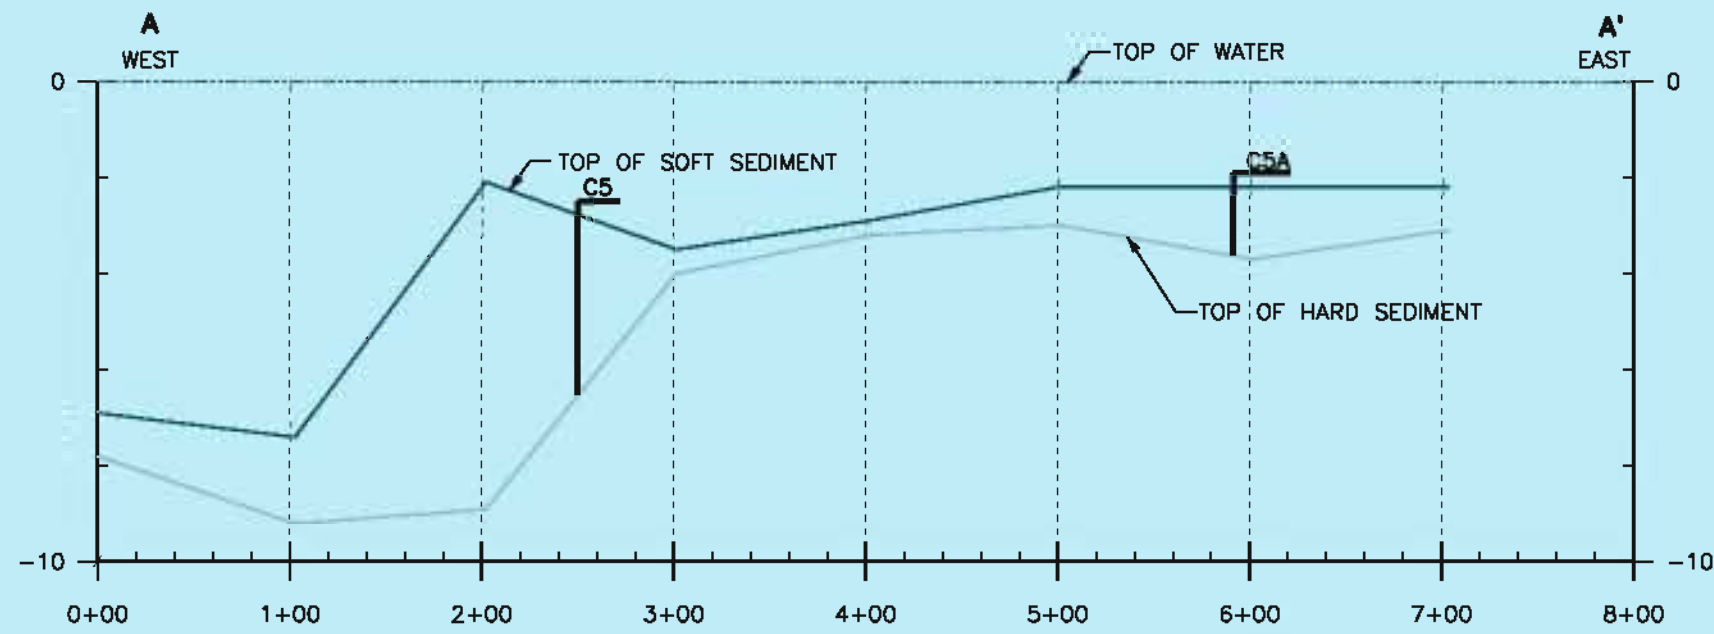
FIGURE 4.1 CROSS SECTION DRAWING (A-A' AND B-B')

C5
SEDIMENT CORE SAMPLE
NUMBER AND LOCATION

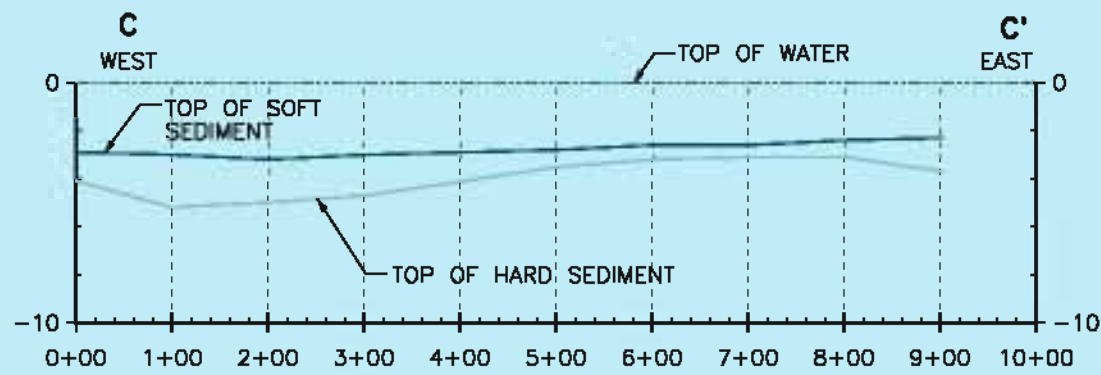
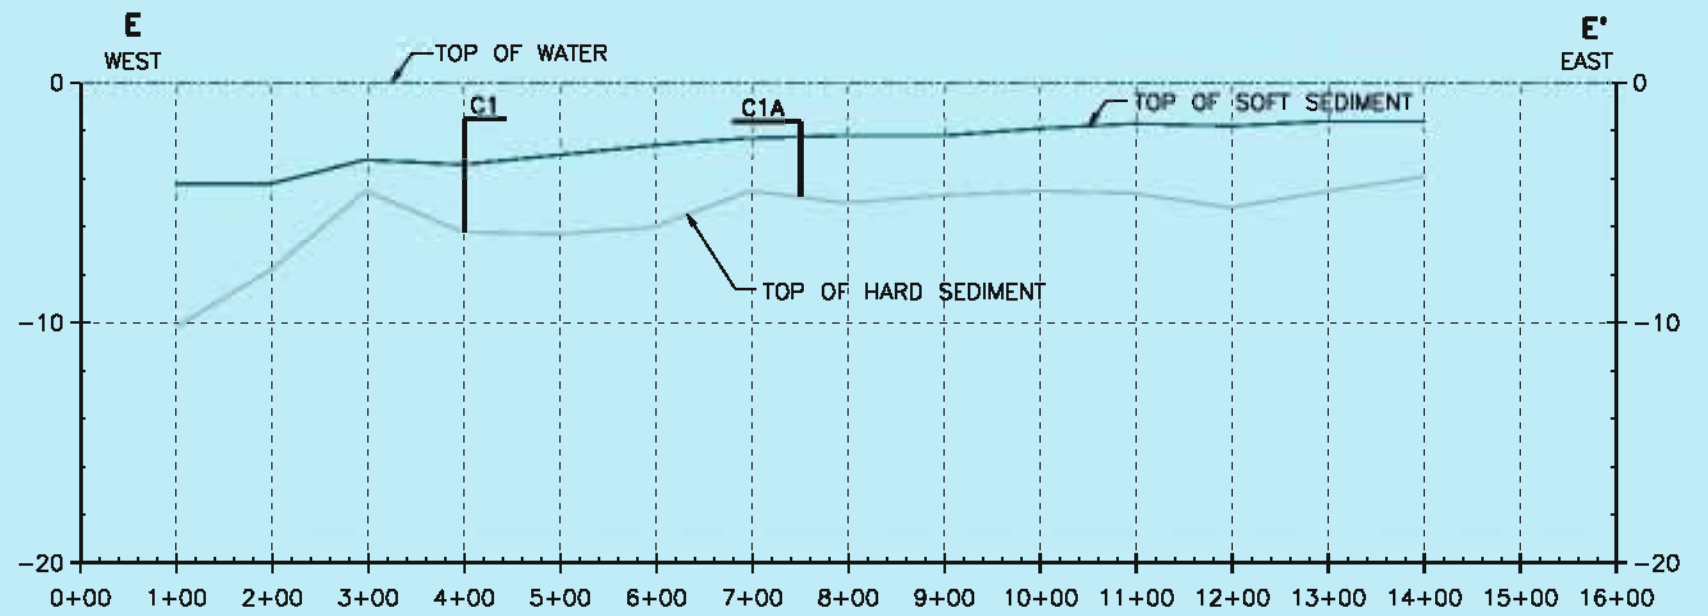
FIGURE 4.2 CROSS SECTION DRAWING (C-C', D-D' AND E-E')

- C2 SEDIMENT CORE SAMPLE NUMBER AND LOCATION
- APPROXIMATE PROPOSED GEOTEXTILE TUBE LOCATION

Under the proposed conditions, the cross sections at HEC-RAS River Stations 21.6 and 21.3 (also referred to as X-Section D-D' and X-Section E-E' on Figure 3) reflected the greatest difference in cross sectional geometry and as a result the greatest change in transport properties. From this data, we anticipate that if constructed as shown in the conceptual design, we would expect increased competency, increased capacity, and an overall increase in the channel's ability to maintain navigable depths. However, the increased transport throughout this reach means that the downstream sections should expect to receive additional sediment.

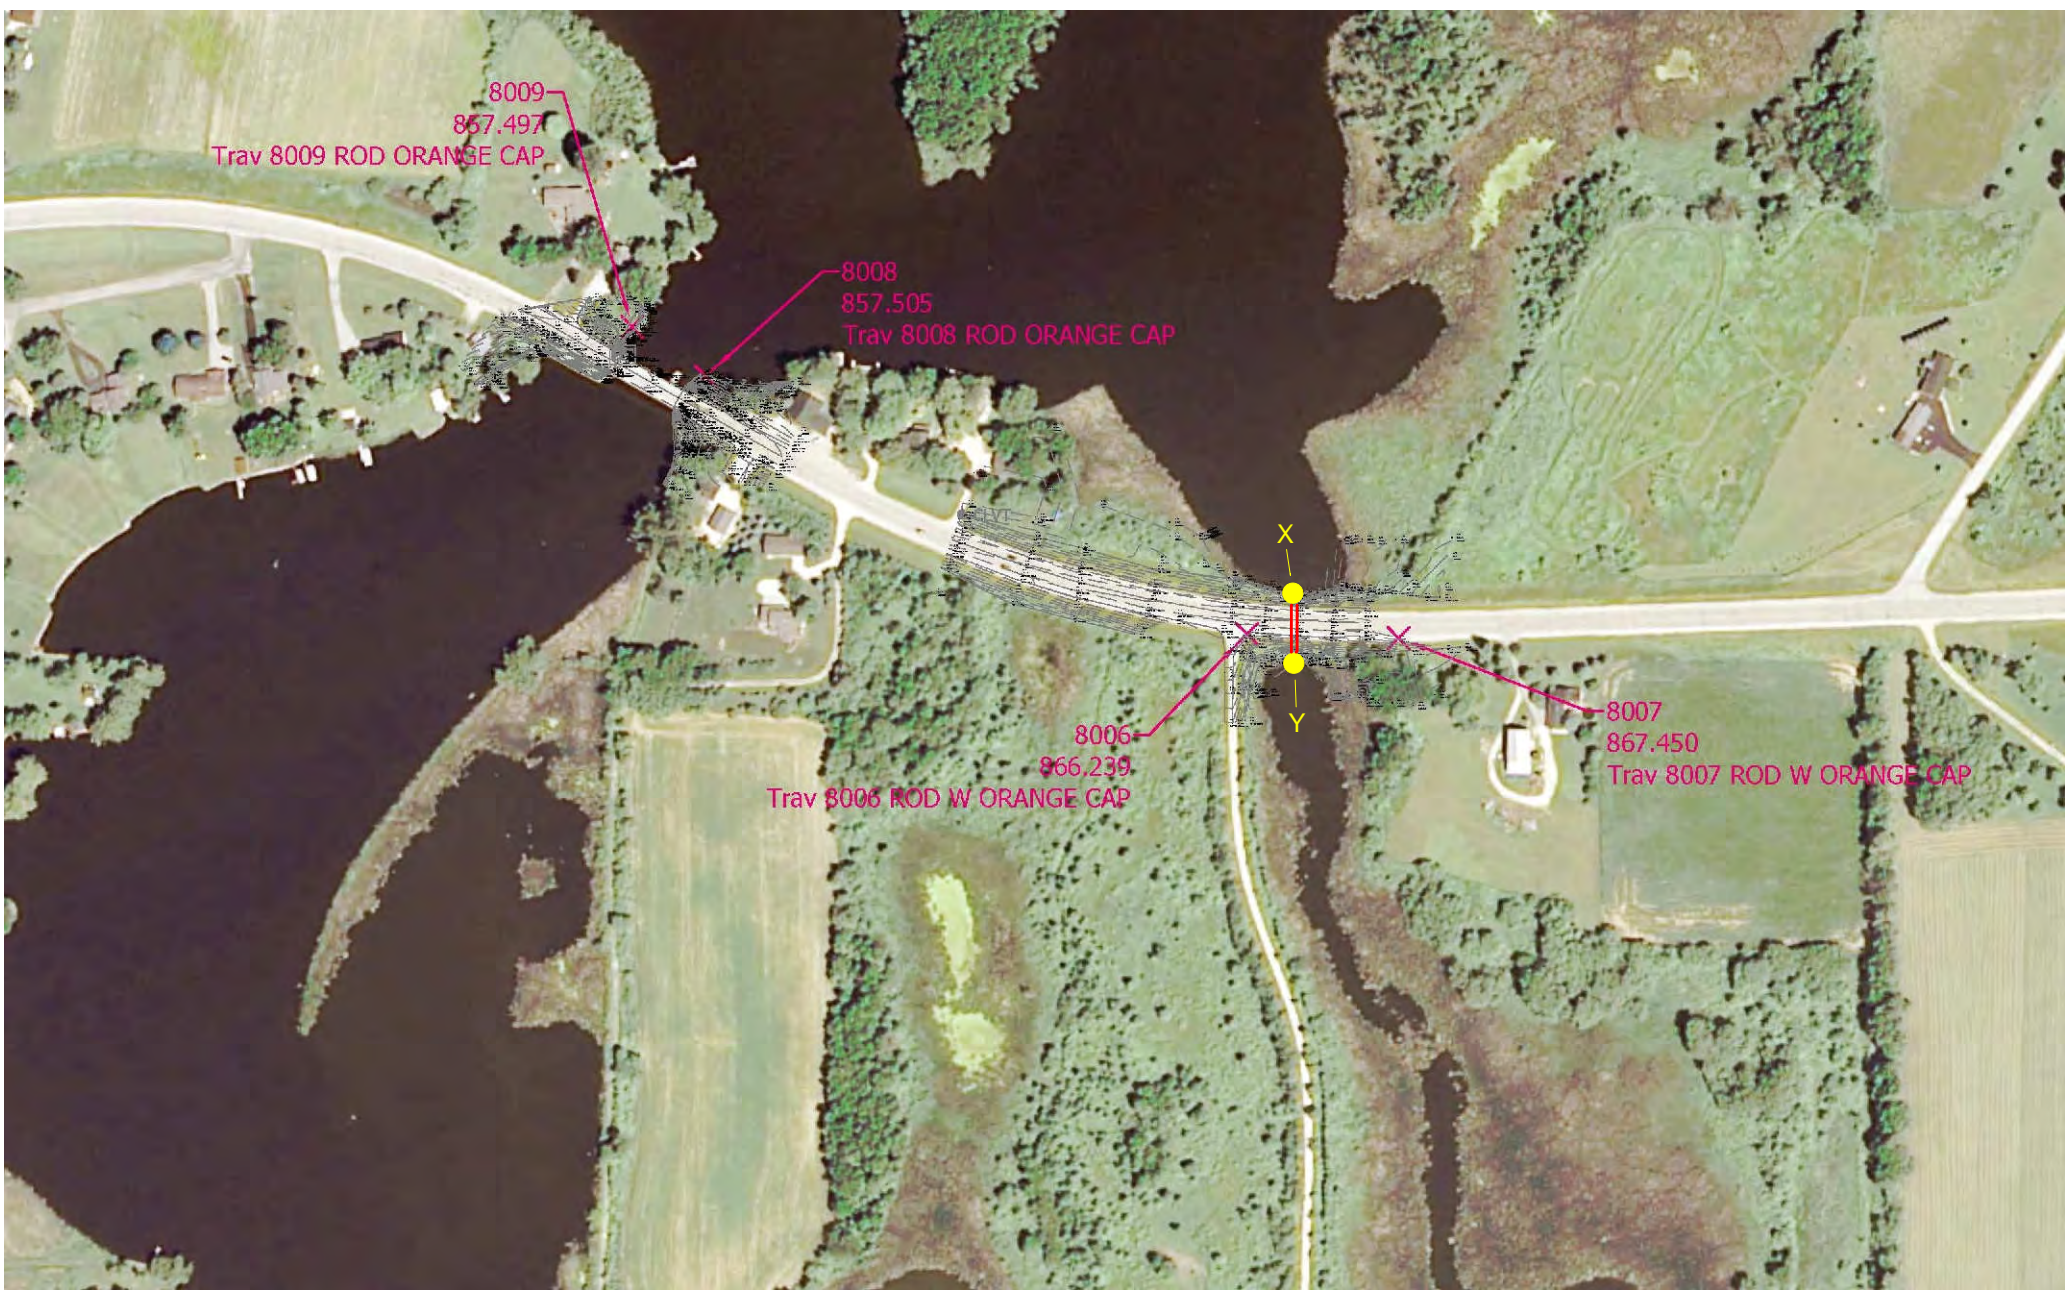
FIGURE 5.1 NORTH TOPOGRAPHIC SURVEY

- X** invert culvert elevation: 855.52ft
- Y** invert culvert elevation: 855.29ft
- ||** culvert

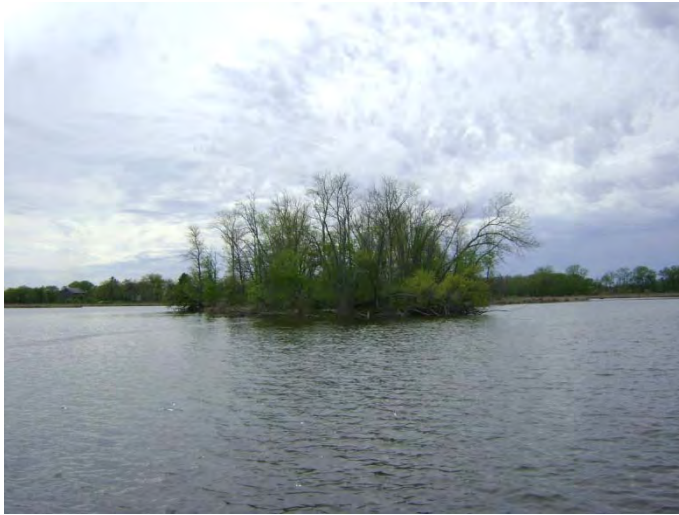
Photo 1: View as shown on Vegetation Communities Figure. Photo was taken looking southwest. Sandbar willow, tag alder red osier dogwood lake fringe with green ash, American elm, black willow interior.

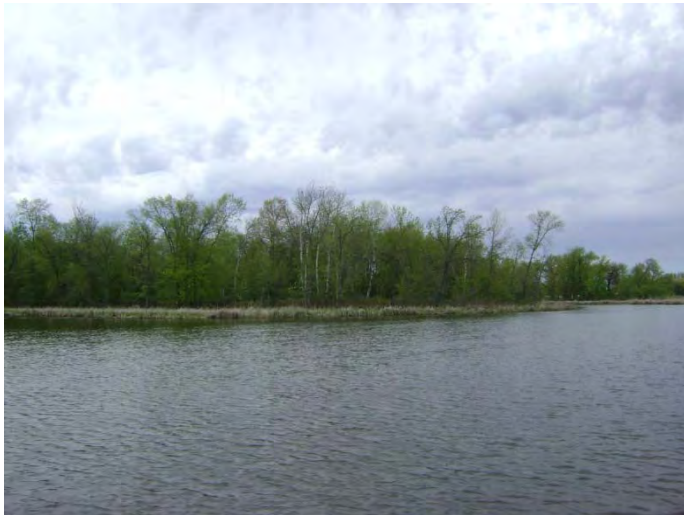
Photo 2: View as shown on Vegetation Communities Figure. Photo was taken looking northwest. Narrow leaved cattail lake fringe, green ash, American elm, quaking aspen interior.

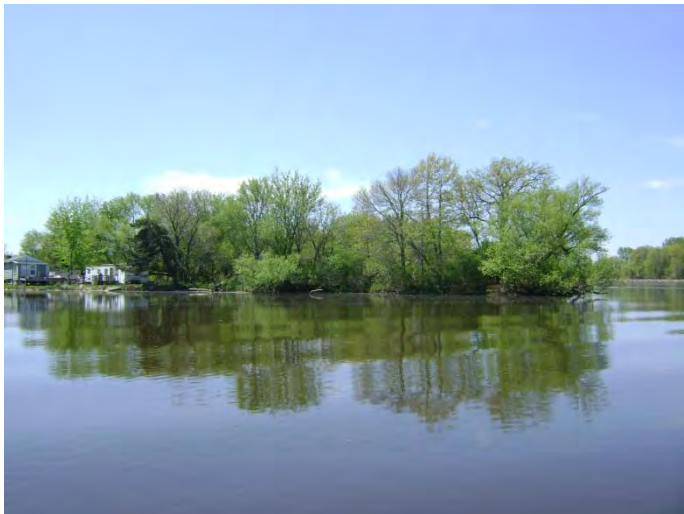
Photo 3. View as shown on Vegetation Communities Figure. Photo was taken looking south. Black willow and green ash lake fringe.

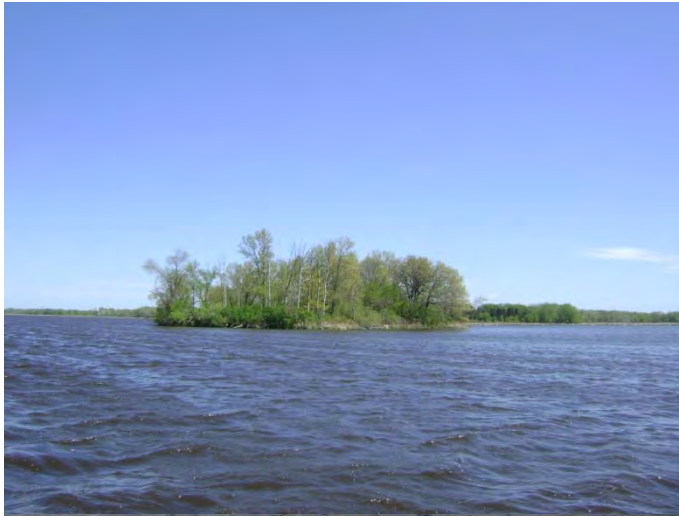
Photo 7: View as shown on Vegetation Communities Figure. Photo was taken looking northeast. Honeysuckle lake fringe with quaking aspen, red oak and green ash interior.

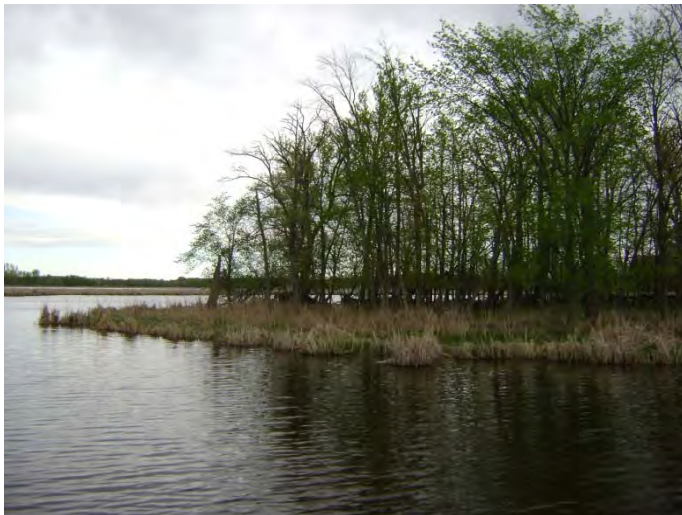
Photo 8: View as shown on Vegetation Communities Figure. Photo was taken looking east. Narrow leaved cattail fringe with green ash, American elm and black willow interior.

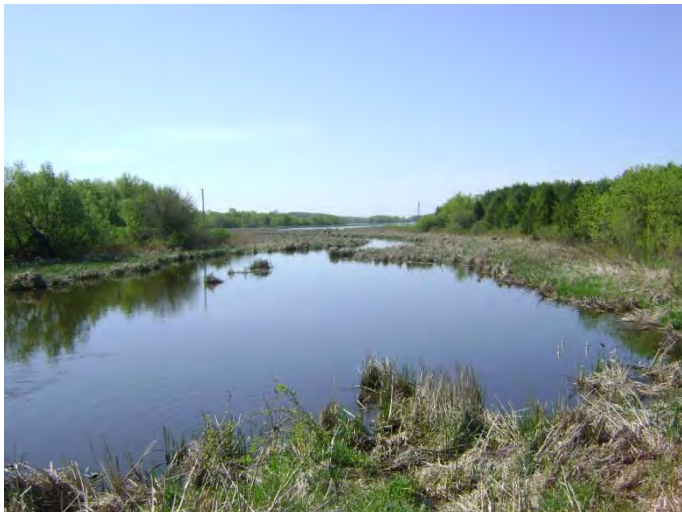
Photo 9: View as shown on Vegetation Communities Figure. Photo was taken looking south. Narrow leaved cattail marsh.
