**LAKE SINISSIPPI IMPROVEMENT DISTRICT  
ANTHONY ISLAND SHORELINE AND NEAR-SHORE LAKEBED ASSESSMENT  
AND SHORELINE RESTORATION PLAN**

Eco-Resource Consulting, Inc.

January, 2018

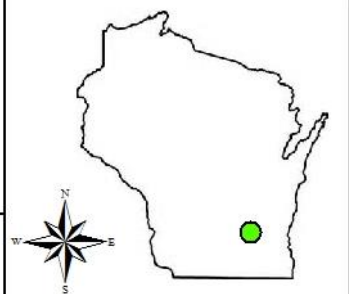
Figure 1

The consensus of LSID members is that Anthony Island, particularly the southern and western shorelines of the island have been receding at an accelerated pace. Based on aerial image comparisons from 1941 aerial imagery to modern times, the shoreline has receded anywhere from 30 to 60 feet (Appendix A, Figure 1). The LSID has elected to move towards a proactive solution to reduce shoreline recession and stabilize the shorelines with appropriate hard and/or soft armoring methods.

through the drainage valley have resulted in a series of terraces upslope from the top of the bank. This continued process has resulted in a maximum of 54 feet of shoreline recession here since the 1940s (Figure 1).

Figure 1. 1940 vs 2017 Shorelines  
Lake Sinissippi Impoundment District  
N5226 Wildcat Road  
Iron Ridge, Wisconsin 53035  
Section 09 T10N R16E  
Town of Hustisford, Dodge County

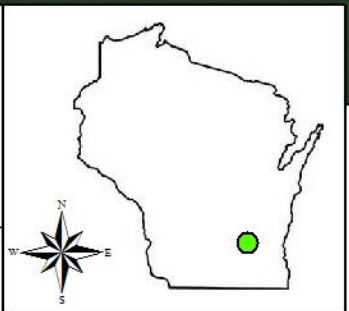
Figure 2

Several small spatial areas of invasive species exist along the shoreline. These species include Asian honeysuckle (*Lonicera sp.*), common buckthorn (*Rhamnus cathartica*), black locust (*Robinia pseudoacacia*), Asian bittersweet (*Celastrus orbiculatus*), winged euonymus (*Euonymus alatus*), reed canary grass (*Phalaris arundinacea*), and purple loosestrife (*Lythrum salicaria*). Of these invasive species, Asian honeysuckle was the most prevalent and was found in numerous locations on the west and southwest shorelines. A clonal population of mature black locust is associated with the steepest bank area along Shoreline Zone 4. Remaining invasive species were found in isolated locations in relatively low density as indicated on Figure 2.

Vegetatively, the banks are mostly devoid of herbaceous vegetation, with some spatial areas of Pennsylvania sedge, common woodland sedge, and mosses overhanging the banks. Hardwood leaf litter is dense up to the crest of the bank. Woody vegetation in SZ-1 is primarily comprised of mature native trees, with a few select mature common buckthorn trees near the north end (SRP-A). Green ash, shagbark hickory, aspen, maple (silver, red, and sugar) and oak are common and tree roots are typically exposed and undermined at the bank. Most mature trees on the bank are leaning over the water. A significant amount of dead trees lie in the water, and numerous shoreline trees have dead or dying limbs overhanging the water. Native shrubs exist in clonal thickets periodically at the bank and further inland. Shrubs include American hazelnut, red osier dogwood, gray dogwood, nannyberry viburnum, and highbush cranberry. A single oriental bittersweet plant and a single winged euonymus plant was found (locations indicated on Figure 2).

Figure 2. Invasive Species  
Lake Sinissippi Impoundment District  
N5226 Wildcat Road  
Iron Ridge, Wisconsin 53035  
Section 09 T10N R16E  
Town of Hustisford, Dodge County

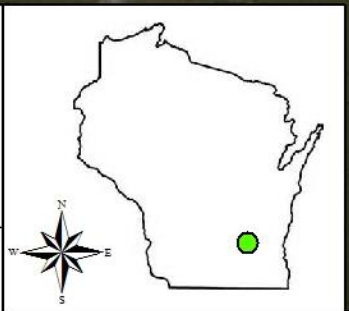
Figure 4

Fifty-five feet of topographical relief exist on the south half of the island from the apex of the drumlin to the lake. With numerous ridges and valleys, four distinct sub-watersheds drain surface water to the lake (Figure 4).

Two soil test pits were advanced on opposite sides of the island. Each test pit was advanced within 10-20 feet of the top of the bank in upland position. Soil test pit locations are indicated on Figure 4.

Figure 4. Drainage Patterns & Shoreline Zones  
 Lake Sinissippi Impoundment District  
 N5226 Wildcat Road  
 Iron Ridge, Wisconsin 53035  
 Section 09 T10N R16E  
 Town of Hustisford, Dodge County

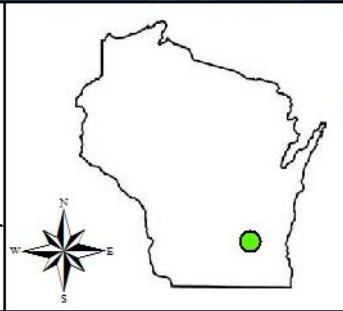
Figure 5

Two soil types are mapped by the Natural Resource Conservation Service (NRCS) on the south half of the island, as indicated on Figure 5. The west half of the island is mapped as Kidder Loam, 6-12% slope, eroded. The east half of the island is mapped as Kidder Loam, 20-30% slope, eroded.

Figure 5. NRCS Web Soil Survey  
Lake Sinissippi Impoundment District  
N5226 Wildcat Road  
Iron Ridge, Wisconsin 53035  
Section 09 T10N R16E  
Town of Hustisford, Dodge County
